RE: *Property Condition Assessment: 111 No Name, Dallas, Texas 75201*

## 1.1 Property Summary

**Address:** 111 No Name, Dallas, Texas 75201

**Property Usage:** Apartment Complex

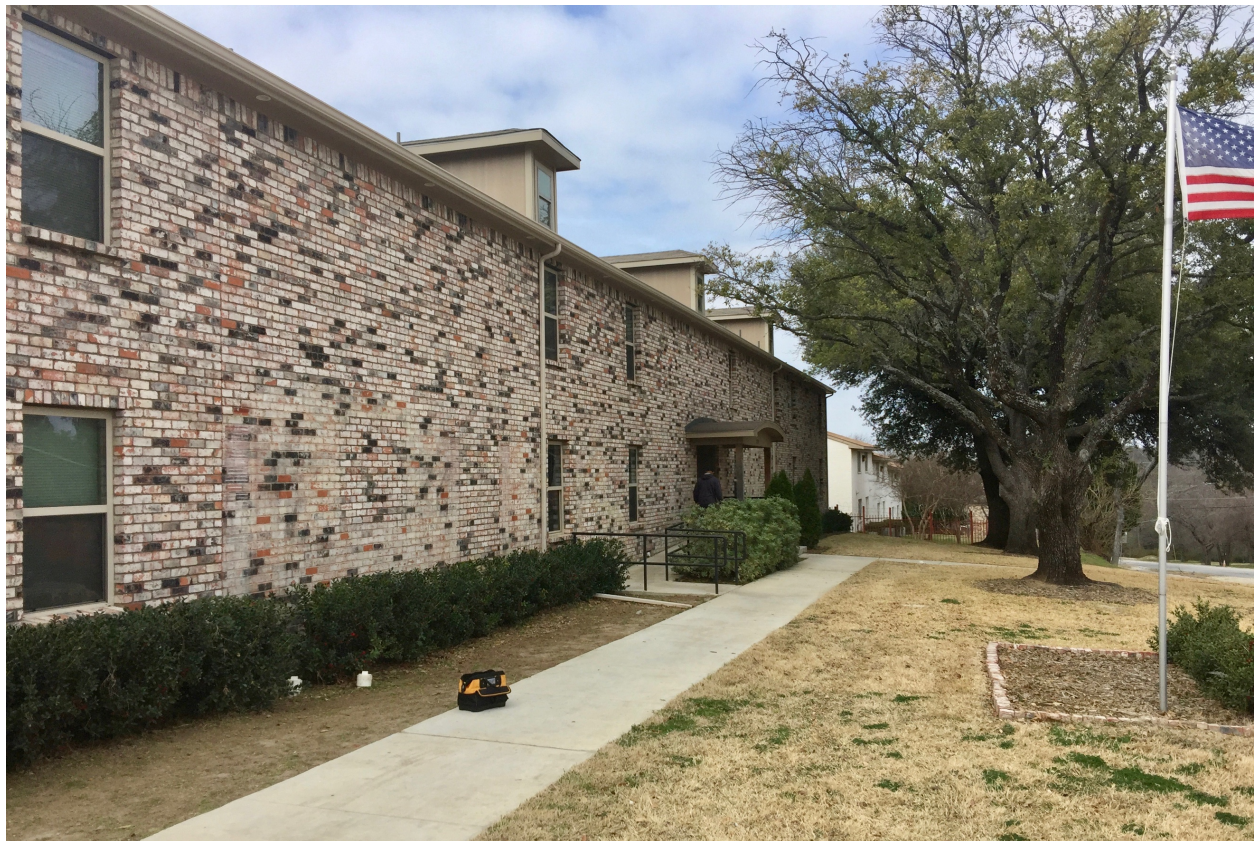
*The north and west side of the property have a gently sloped yard that allows run-offs to carry heavy rain away from the structure into the local creek which is sufficient. There is a drop off approximately 28 inches on the west side of building (slope: 4.9 degrees away from structure).*

*The east end of the building is low and has a negative (-2.4 degree) slope toward the structure on the north-east end which allows storm and irrigation water to accumulate and possibly enter the crawl space of the building structure under the unit (114) that was inspected. The interior courtyard is sloping negatively toward the north-east and appears to be fed by an underground spring.*

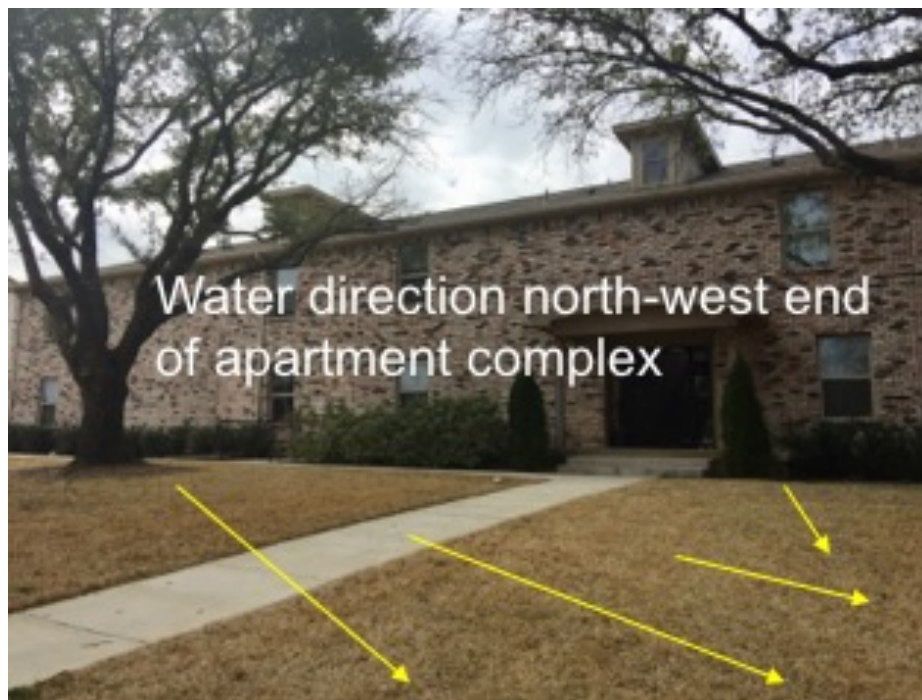
***Water removal in this area is adequate to protect the building foundation  
Looking south-east from front of building on Highland.***

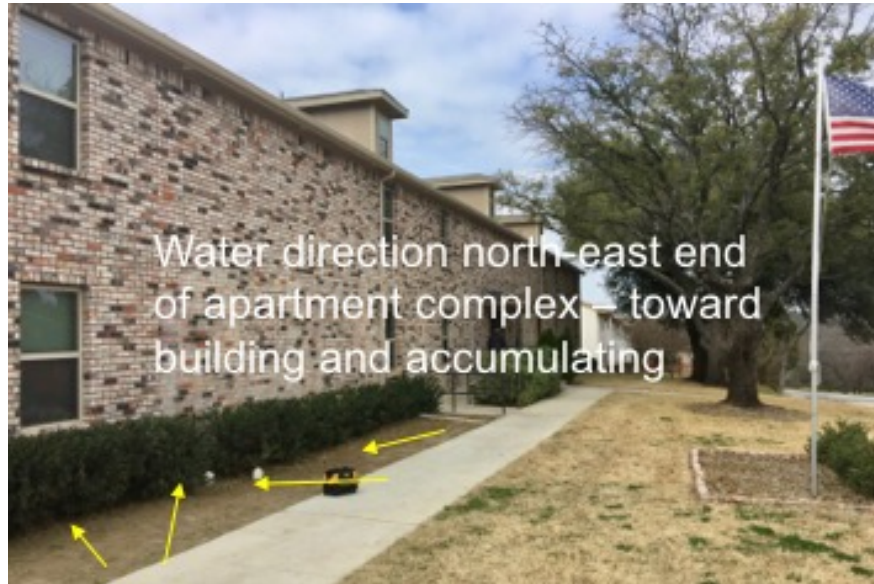
***Water run-off at this end of building is not adequate to protect the foundation and structure and should be further evaluated for remediation***

Water direction north-east end of apartment complex – toward building and accumulating

Regrade the front east end of building flower beds to prevent standing water	Minor – Maintenance Self-Adjustment at designated locations as determined from survey.	Bring in additional top soil, gravel or mulch to front beds. Install French drains to carry excess water away including from gutters that are currently allowing storm water to enter the flower beds at the north-east end of building	\$425.00
		<b>BUGETARY QUOTE ONLY</b>	<b><u>\$3505-3705</u></b>

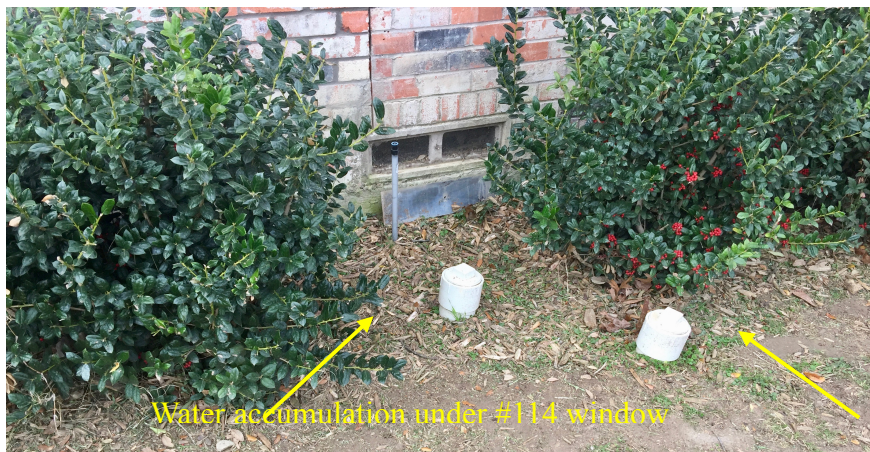
Water accumulation under #114 window

***Front flower bed at Unit 114 indicated the presence of standing water and subgrade penetration of moisture.***

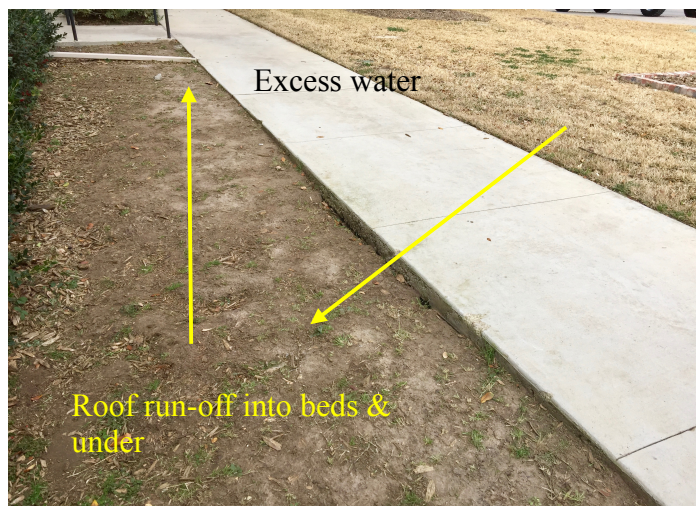
Excess water

Roof run-off into beds & under

***Run-off from gutter kick-outs is into the flower bed allowing more water to stand and accumulate in this area.***

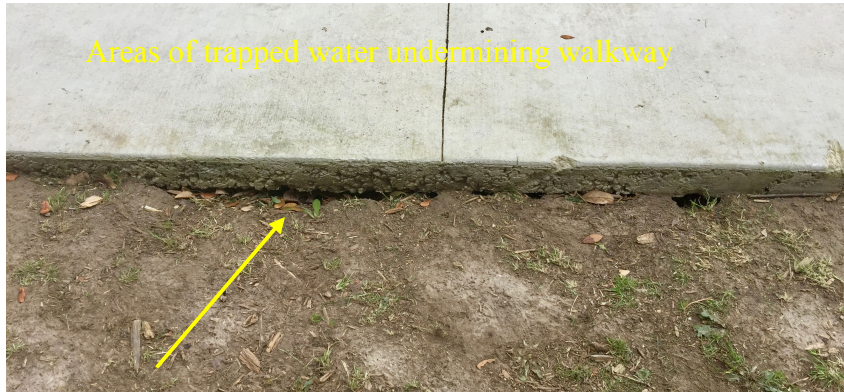
***Migrating water is undermining the sidewalks to flow north toward street.***

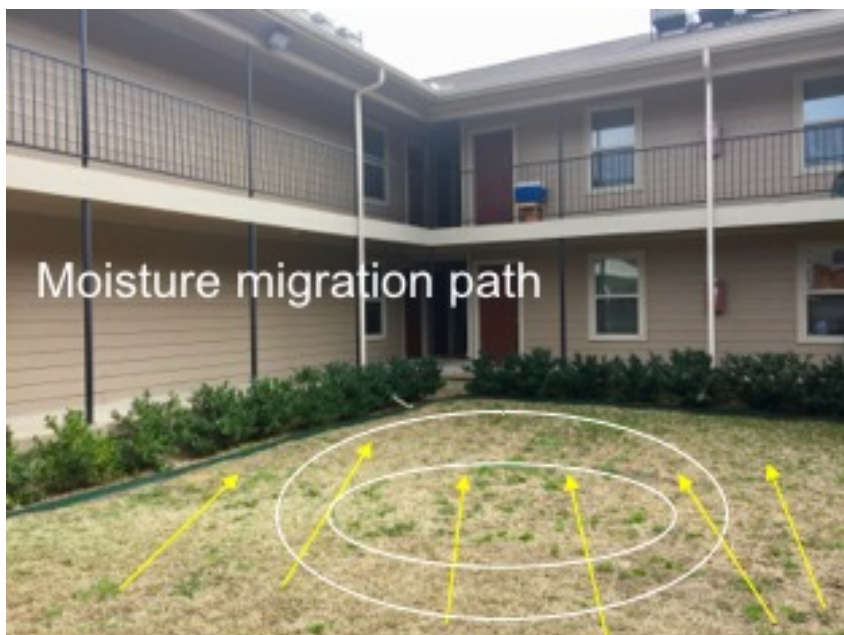
***Courtyard was observed to be migrating water toward the north-east corner of the courtyard. It was not determined what the origin of this water is or at what depths. This is an area for pilot wells to determine depths and volume.***

Engineer an underground collection system to stop the seepage of water under the foundation crawlspace	Additional insulation and addition of ground level and under floor vapor barriers	<ul style="list-style-type: none"> <li>• Engineer 4 hours</li> <li>• Excavation</li> <li>• installation of sump collection boxes,</li> <li>• piping and pumps materials</li> <li>• fan installation and electrical</li> </ul>	\$1600 - \$1800
Install necessary French drains, collection sumps and sump pumps to remove the excess water	Technician installation (or by Kedric)	Suggest minimum two units	\$450

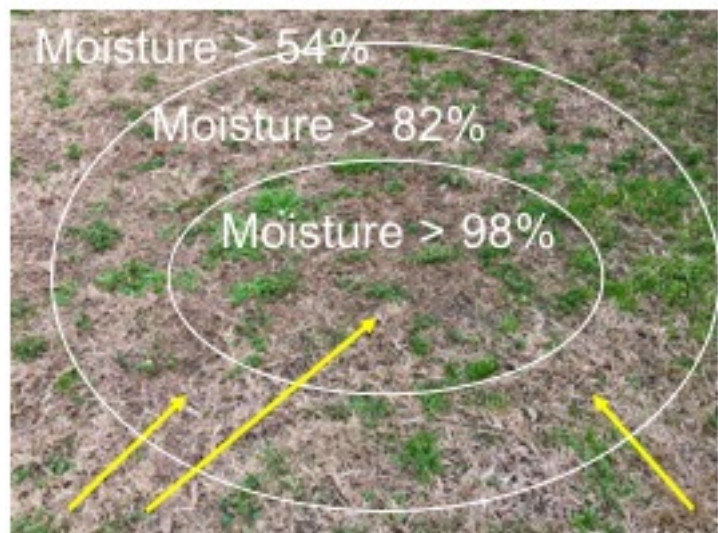
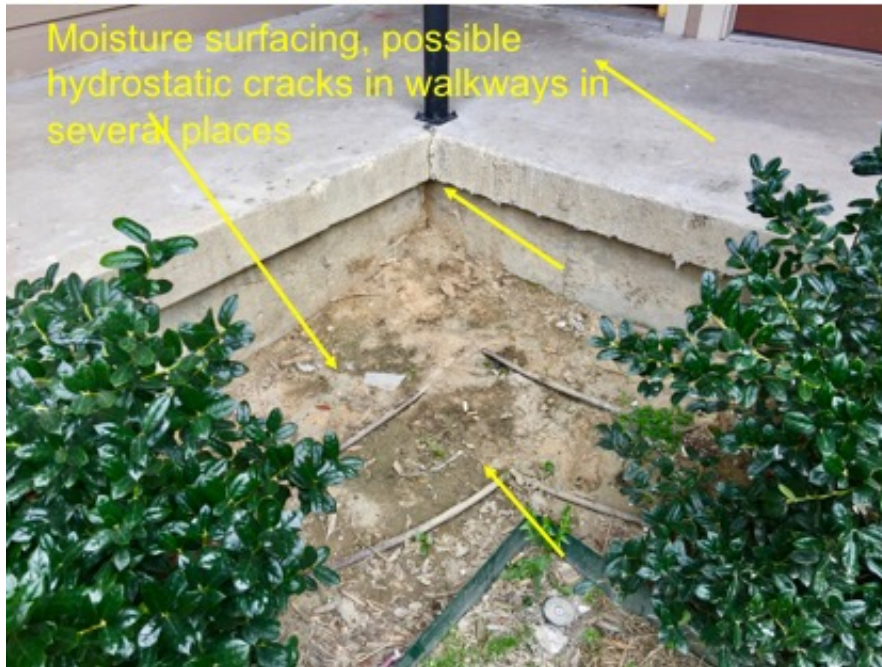
***Turf in this area was measured by means of electronic moisture meter. The readings were extremely high given no rain for past two weeks and irrigation system that has been off for the winter per Kedric Avery, Facilities.***

*The surfacing of water in the area immediately adjacent to Unit 114 from sub-surface water indicates that water migration is occurring most severely in the courtyard (NE corner). Possible hydrostatic*

*cracking was observed in the sidewalks in this area which might indicate uplifting due to moisture. Infra-red scans of interior floors indicate that moisture is intruding consistently within the unit. This would indicate the problem is water vapor rising from the crawlspace rather than a plumbing leak. Blue indicates presence of moisture in subflooring.*
