ARIEL Inspections LLC

PROPERTY INSPECTION REPORT

Concerning: 000 Name Street, Dallas, Texas 75201

February 1, 2017

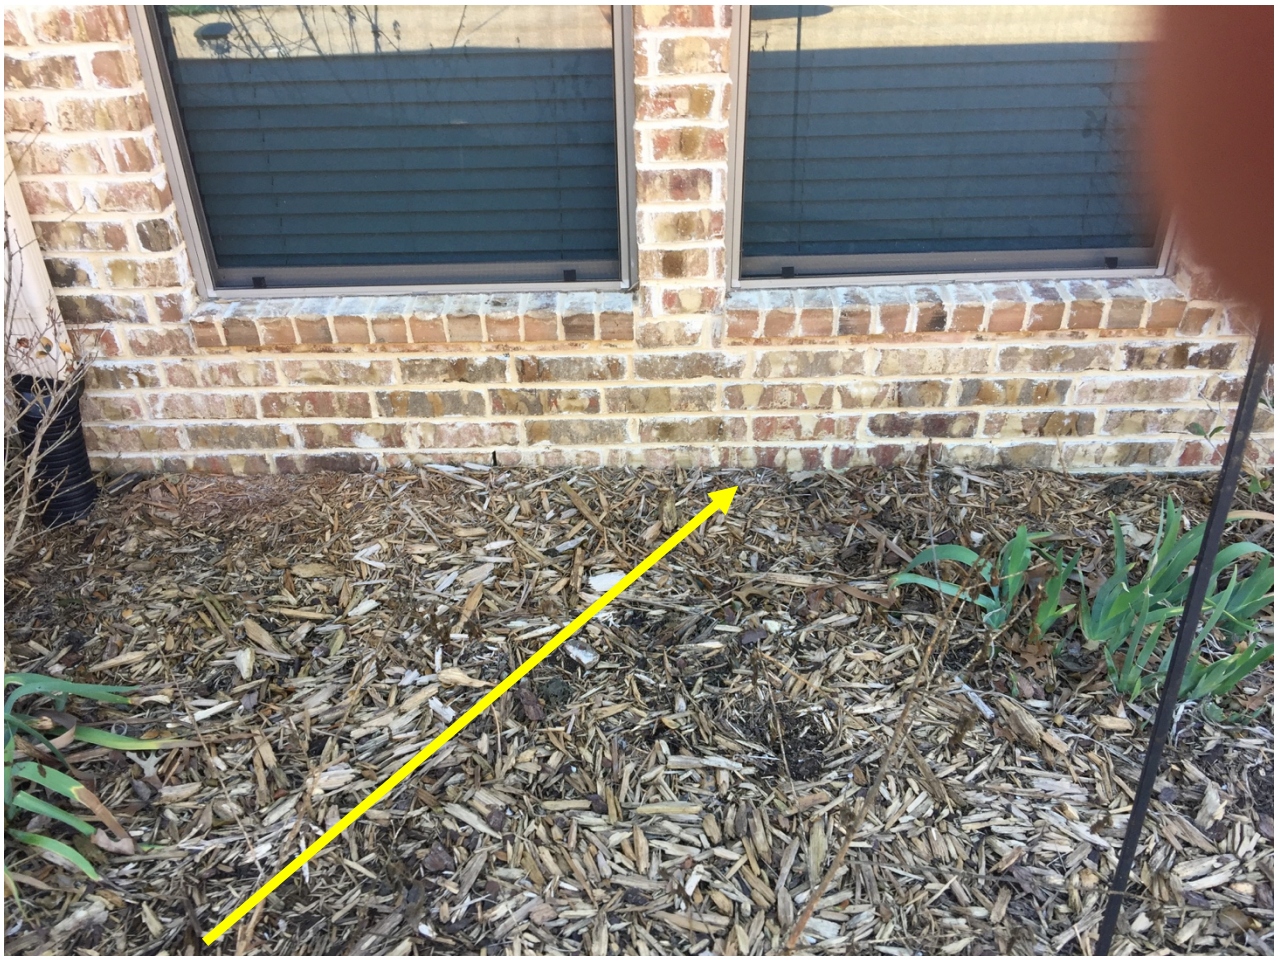
The foundation appears to be supporting the structure & immediate remedial needs are not evident other than removing soil and mulch from the foundation in the back and side yards

Recommendation: These areas on each side should be regraded to assure water drainage away from the home and into a swale or French drains (these appeared blocked with leaves and debris at time of inspection).

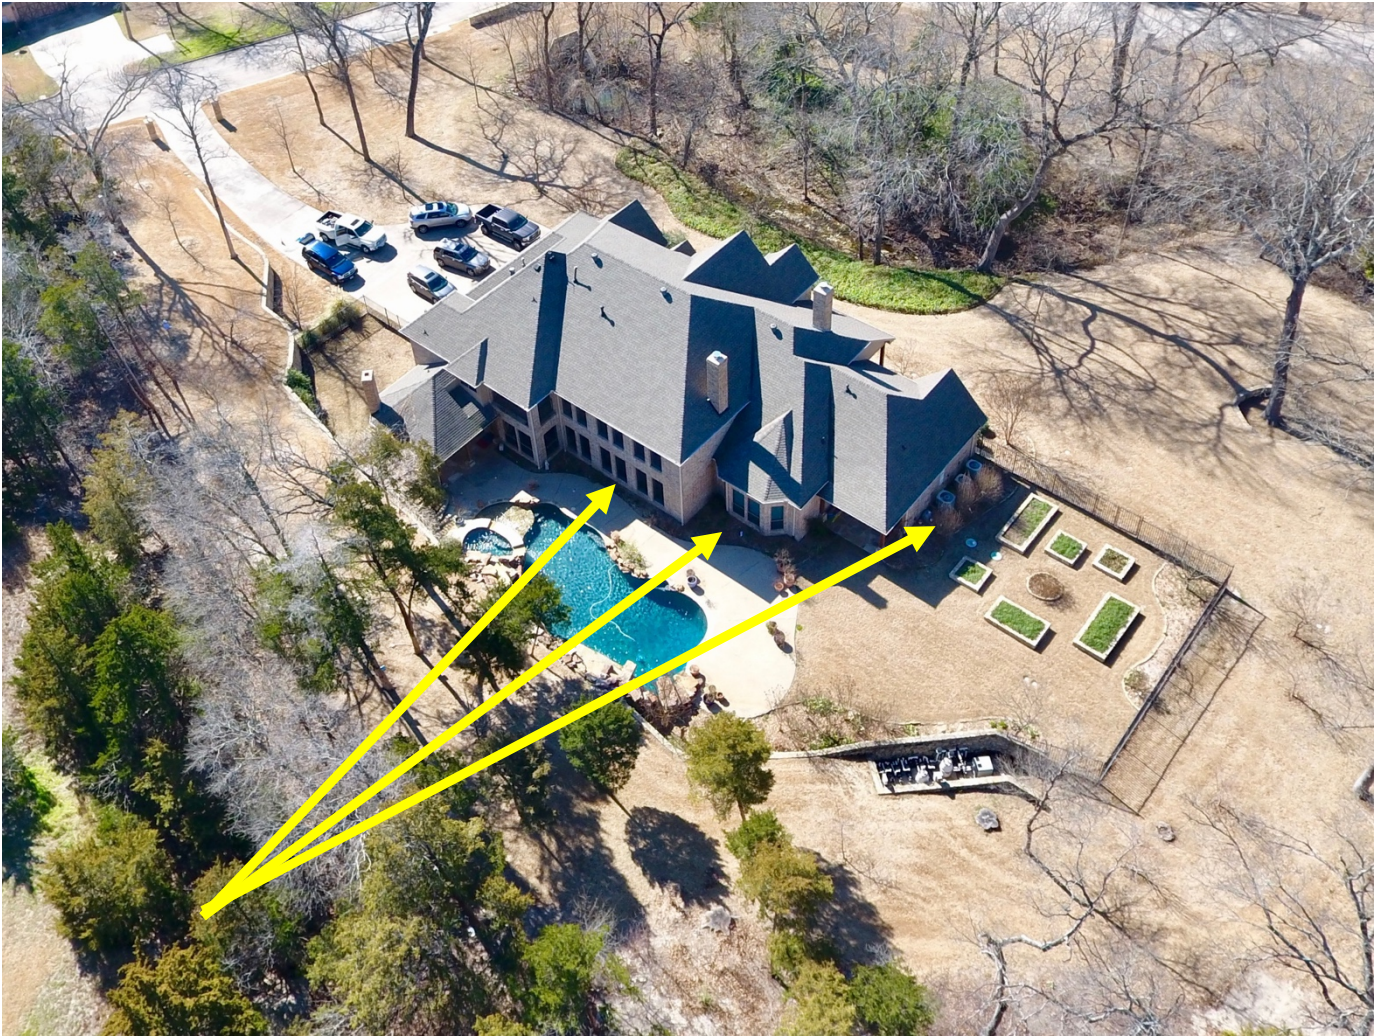
Drainage around house in front and sides is adequate from gutters and kick outs however the flower bed at rear of house adjacent to pool is too high and cover the foundation to the brick veneer and in some areas over the veneer. This allow water intrusion under the slab and may cause future foundation damage from uplifting.

Recommendation: Regrade these areas to below veneer by 4-6 inches. Install French drains clean out as needed to remove standing water from backyard flower beds.

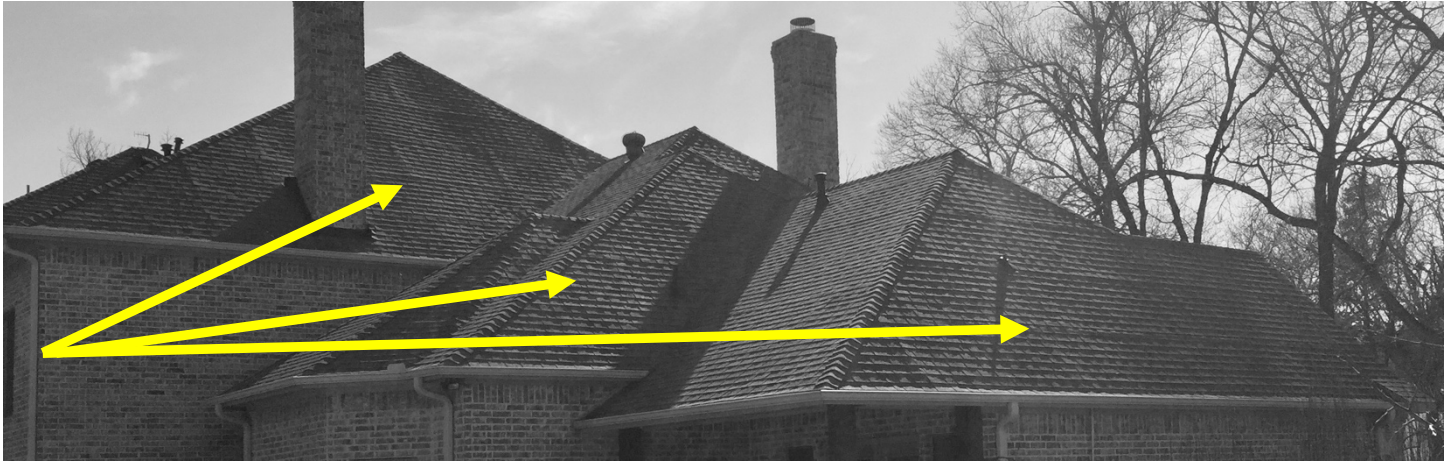
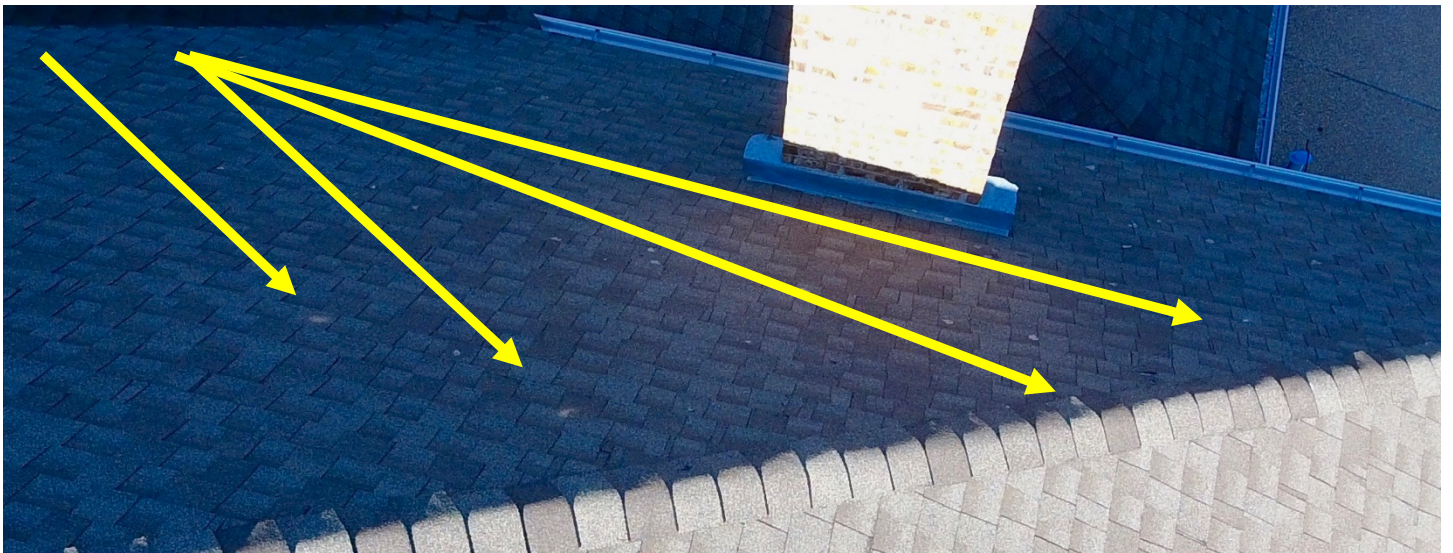
Areas of previous repairs and resealing of hail head pops

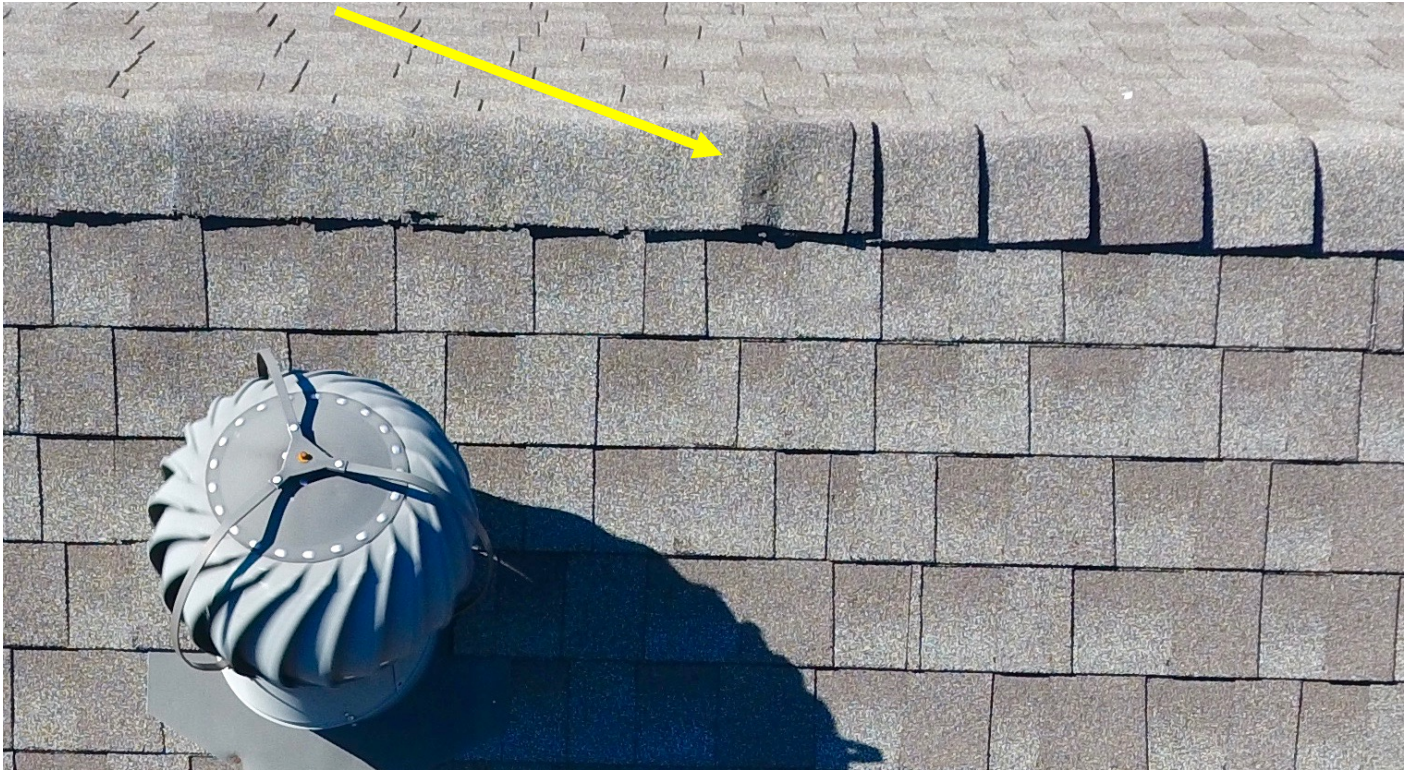
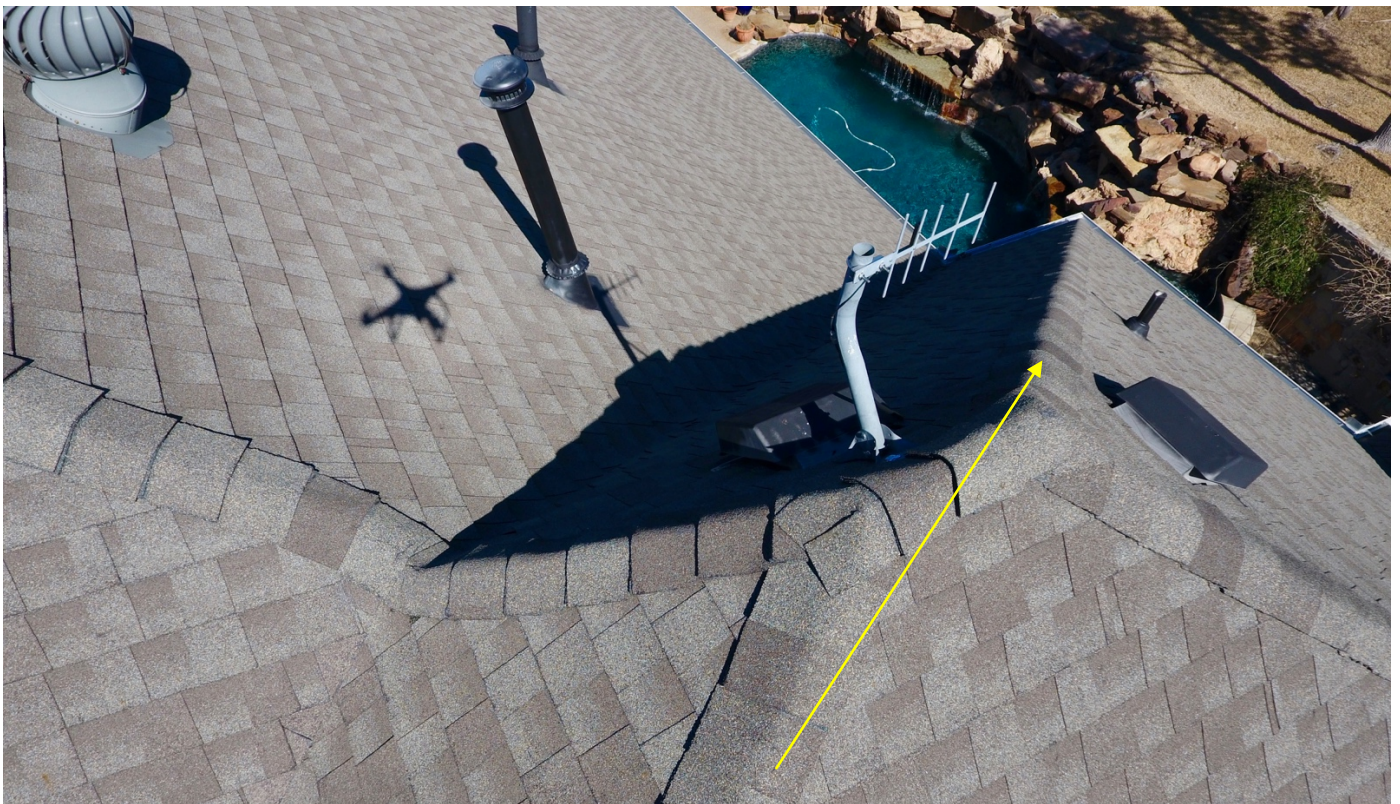
Previously patched and sealed nail heads

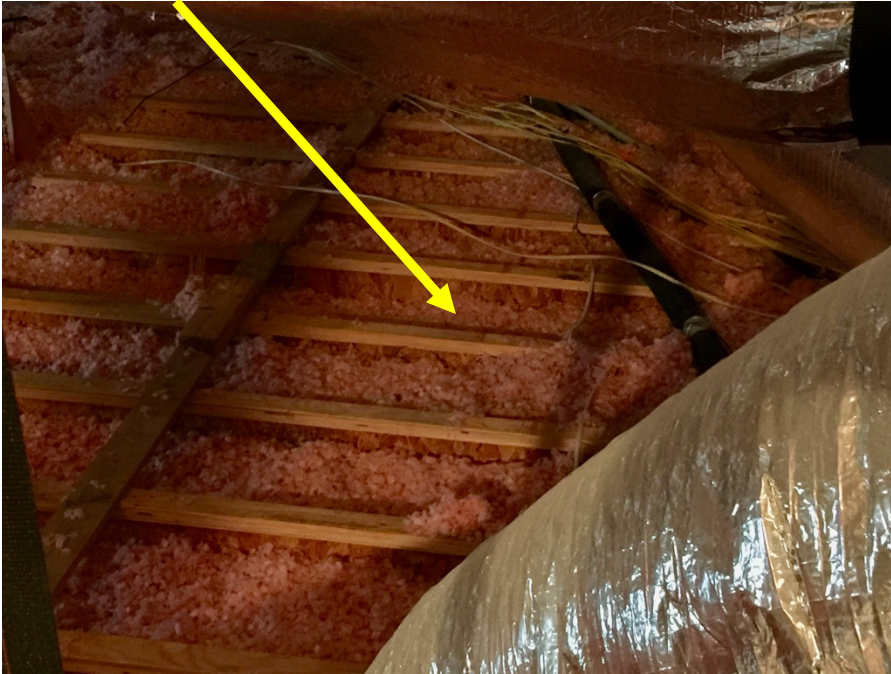
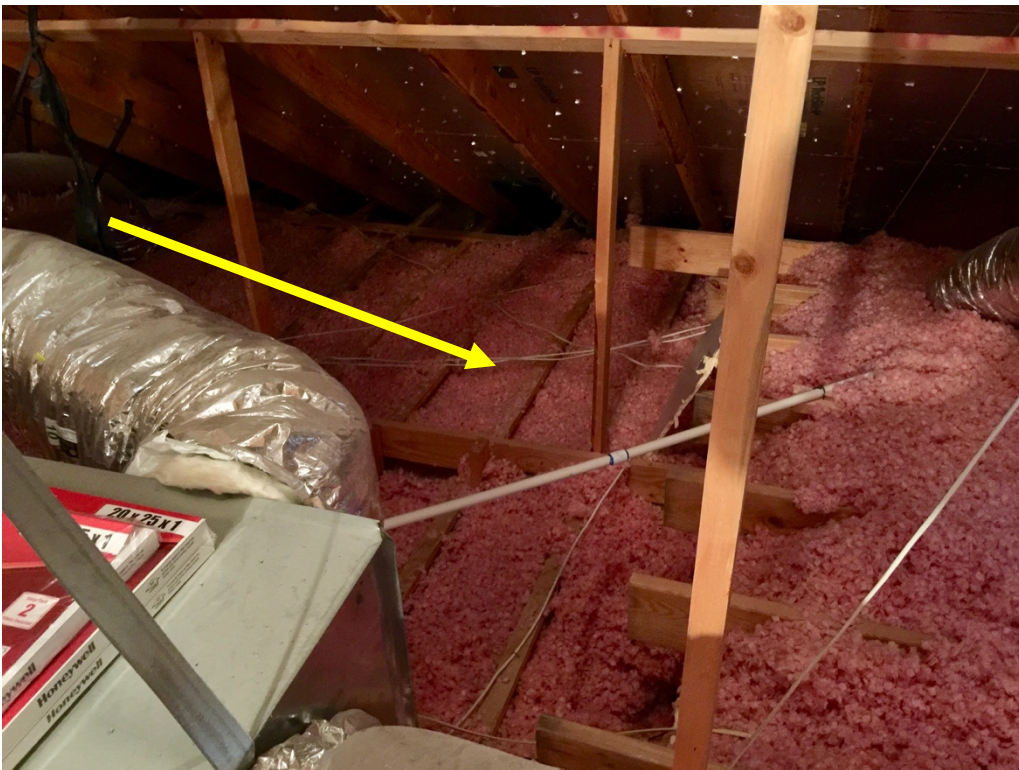
Insulation was noted at being an average depth of approximately 8 inches overall. Some areas were covered with spun fiberglass up to 12 inches deep but some areas were less than 5 inches and a few areas were missing insulation.

Installed Insulation is combination of batts and spun fiberglass. Existing R value is less than R 22.

Recommend increasing with additional Insulation to an average depth of 16-20 inches to increase overall R value to R 30- R 60 per DOE recommendation for the North Texas climate zone.

Ventilation was minimal for the area of attic. Recommend 3-4 additional vents be added either power vents or turtle vents to improve ventilation.

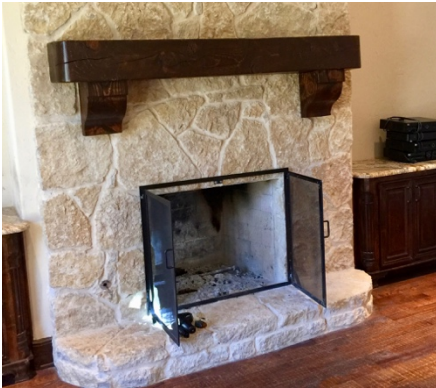
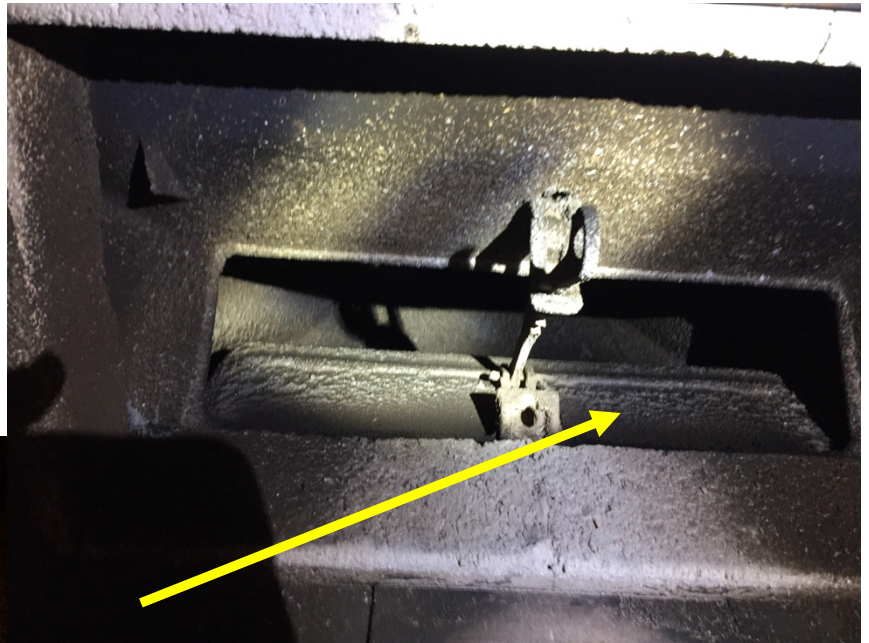
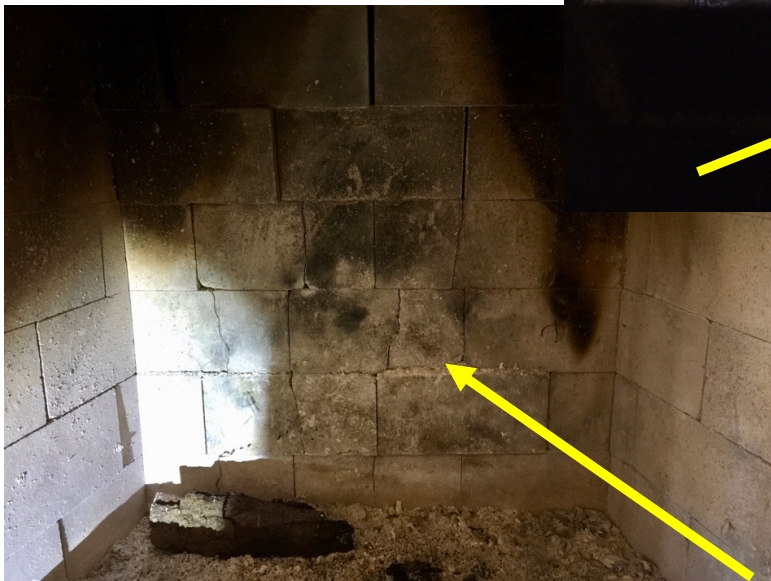
There were cracks noted in the fire brick at back of fireplaces in both rooms

There was excessive creosote buildup on the flue entries on both fireplace

The fireplace firebox mortar should be improved. The rear wall of the fireplace firebox should be repaired for improved safety.

Significant creosote buildup was noted in the fireplace flue and/or firebox. Cleaning of these areas should be undertaken for improved safety.

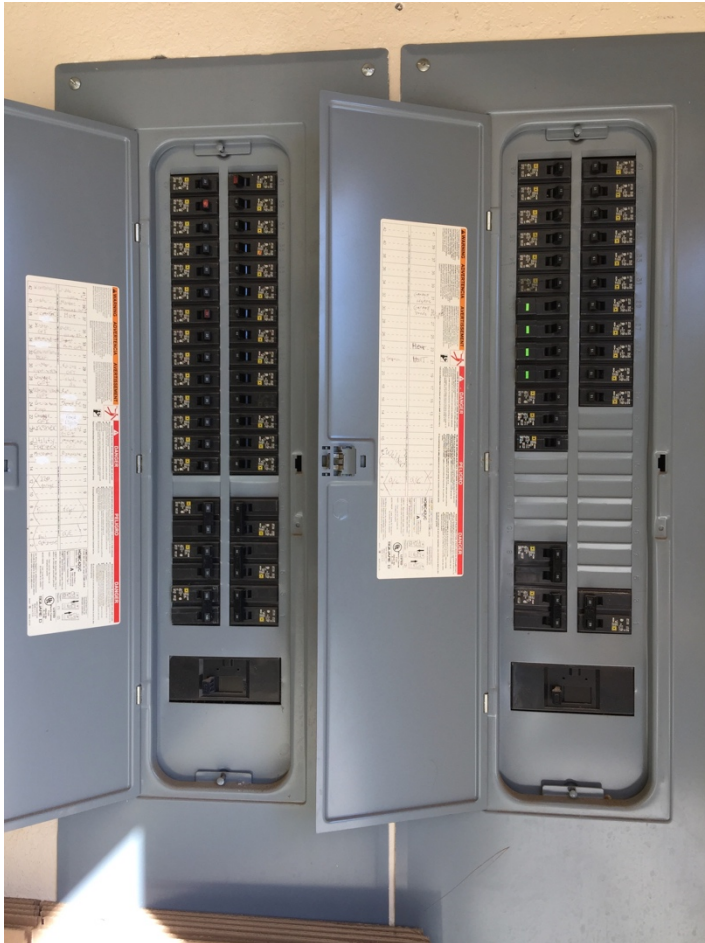
Left hand panel is full and does not provide for expansion

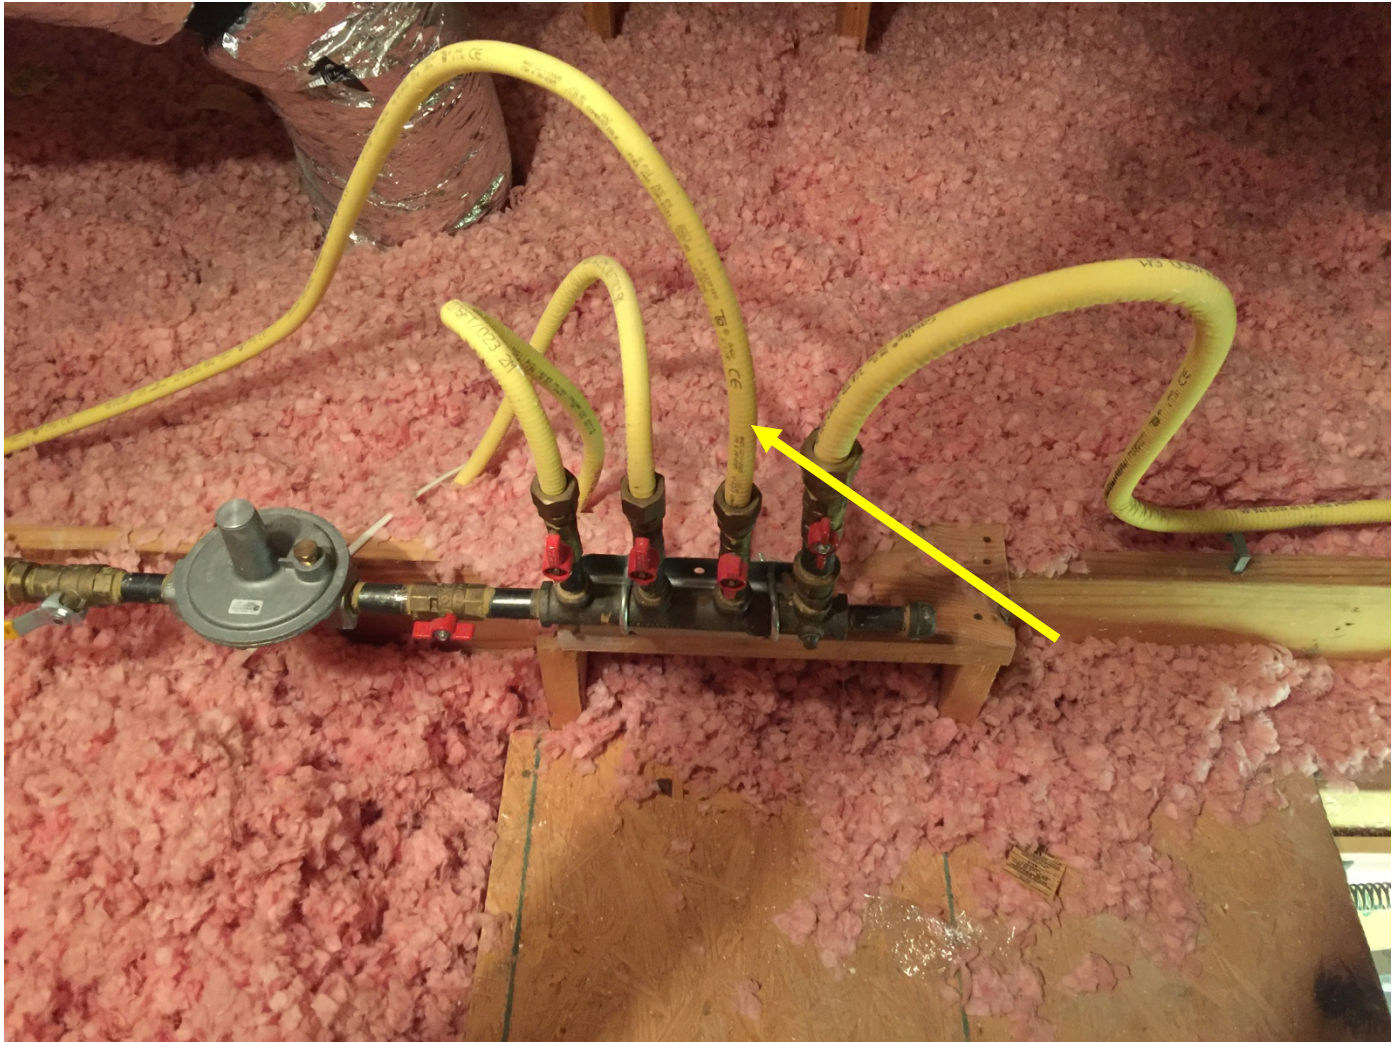
Safety Hazard

CSST (Corrugated Stainless Steel) material is being used for the furnace and other gas lines. This should be inspected by a licensed electrician as it poses a potential safety concern if not properly bonded and grounded.

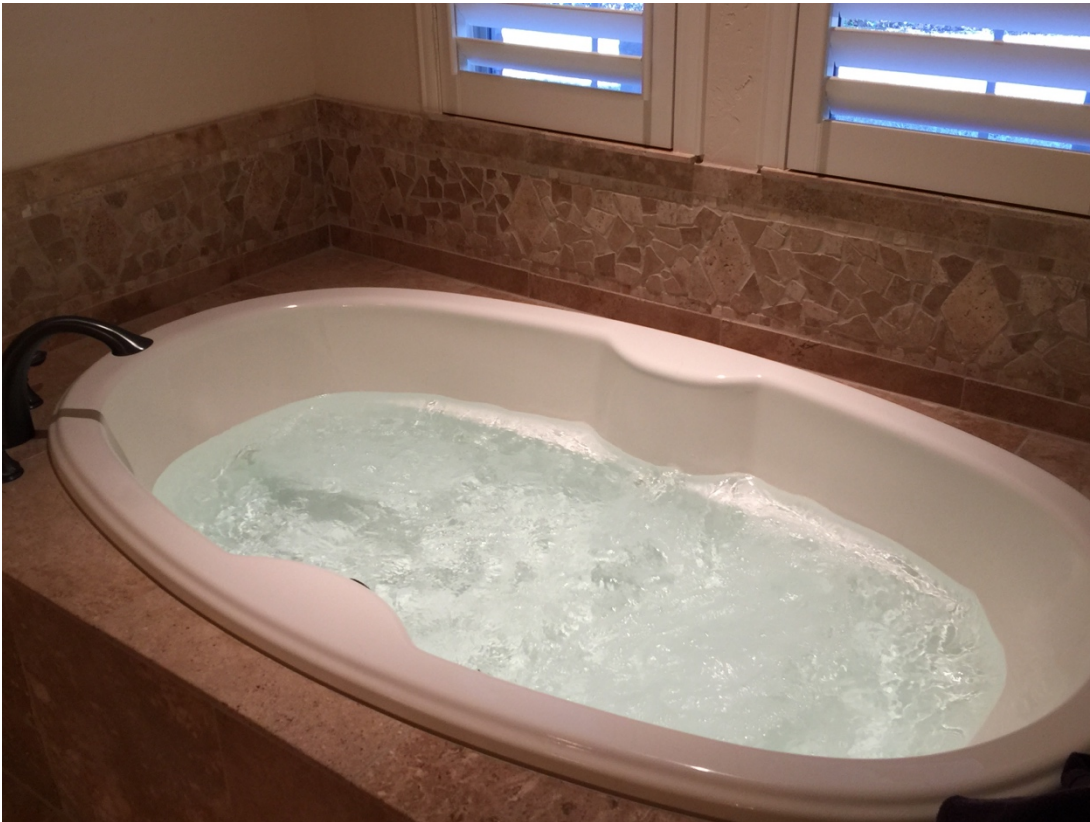
Master Bathroom

Safety Hazard: Hydrotherapy tub: Could not locate on/off GFCI breaker and access to pump equipment was not available

A ground fault circuit interrupter (GFCI) should be installed on the circuit for the whirlpool bath. A ground fault circuit interrupter offers protection from shock or electrocution. This should be repaired as is poses a safety concern.

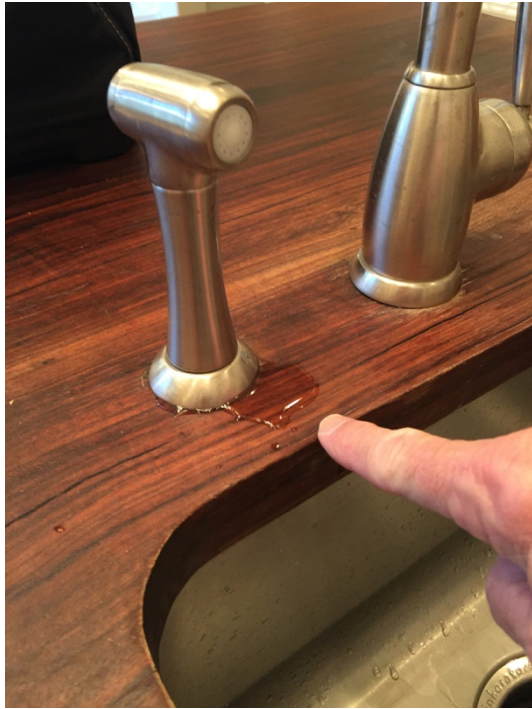
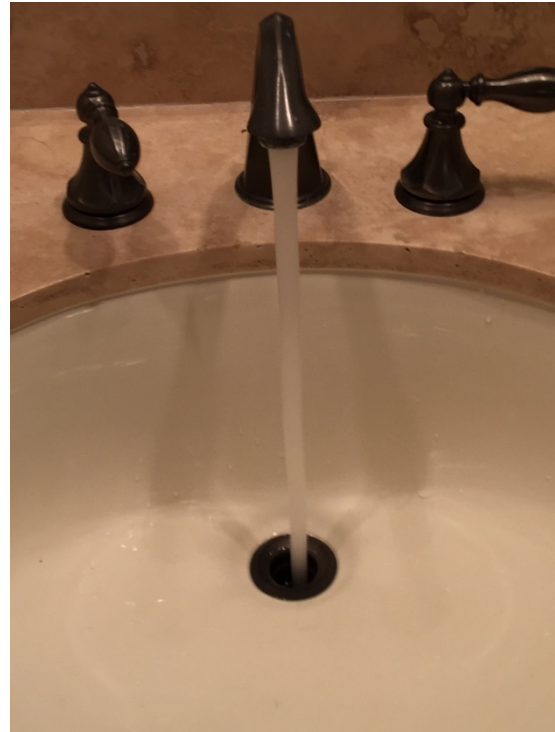
Leaking Sprayer, was noted in the kitchen sink in the center island
Sinks in 3 baths with mechanical stoppers not working properly

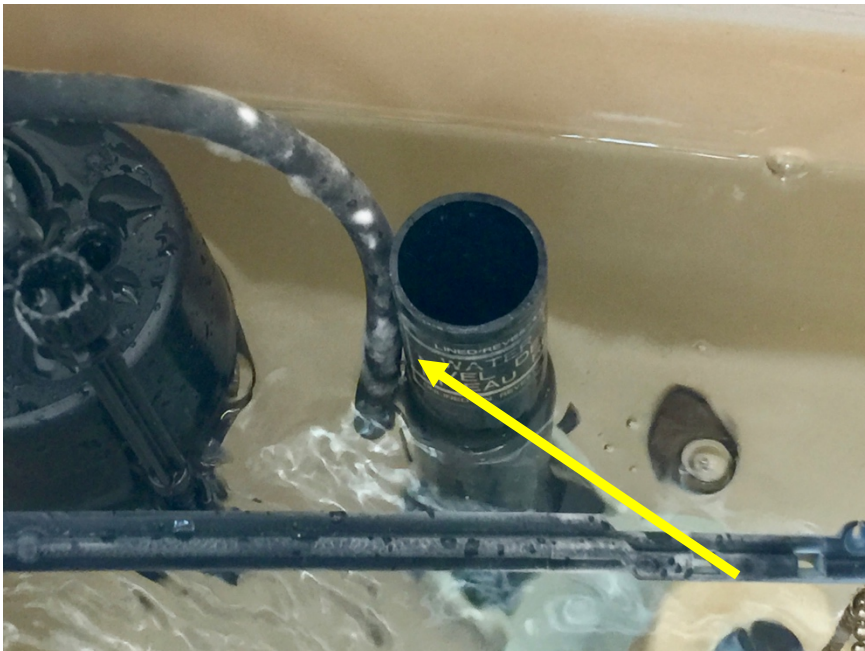
Toilet fill valve was missing air gap. This is a potential for cross connection

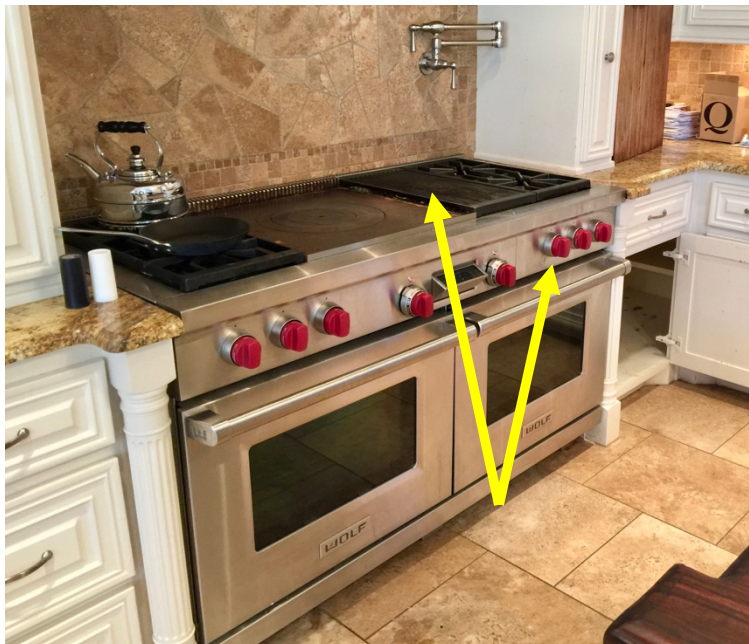
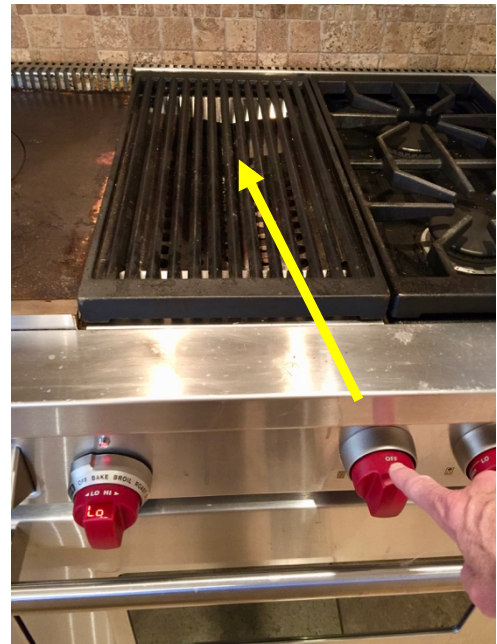
A burner for the range top grill is deficient and did not light properly at time of inspection. The automatic piezo were igniting but the gas did not ignite until contact with the right-hand burners which resulted in a possible explosive action. Safety hazard recommend Wolf service technician test and calibrate/repair prior to any use.

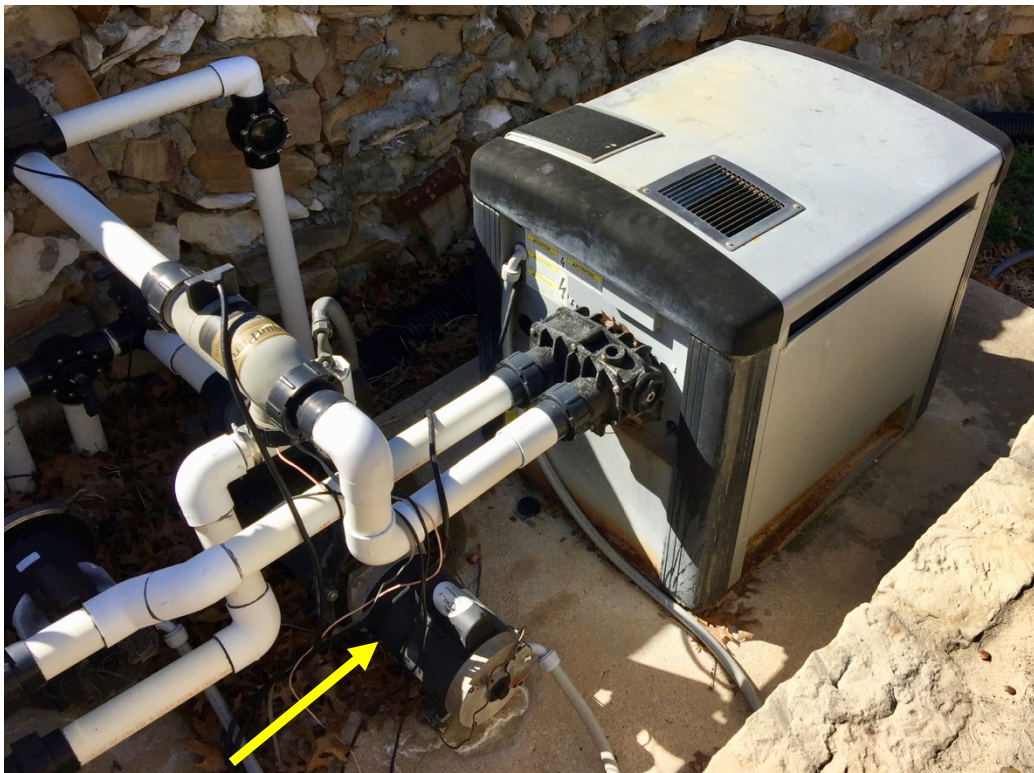
The number one pump arrowed was running hot when inspected with infrared and may be nearly the end of its useful life.

Ages of pumps ranged from 4-9 years old. Recommend monitoring for wear and possible replacement.

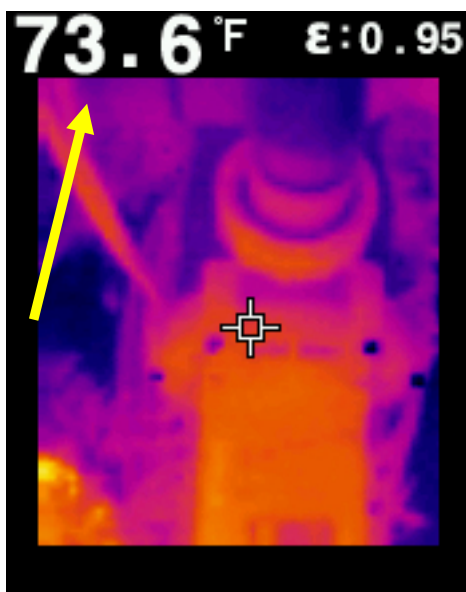
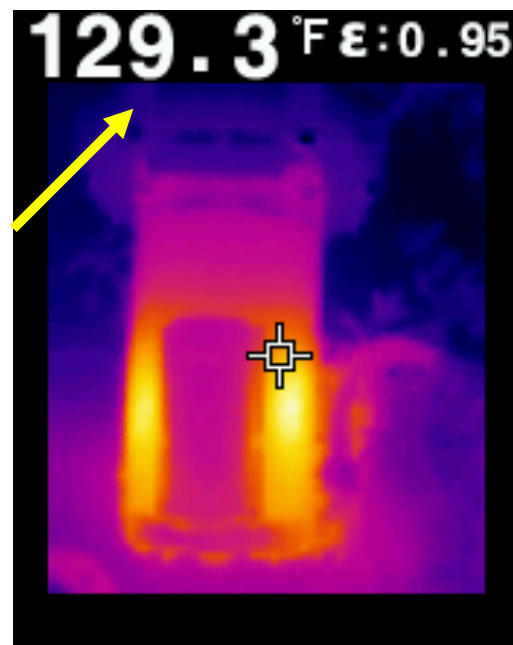
Note thermal scan below comparison of pumps #1 (right) and pump #2 (left) temperature is more than 65 degrees warmer indicating bearing or armature wearing out and close to replacement

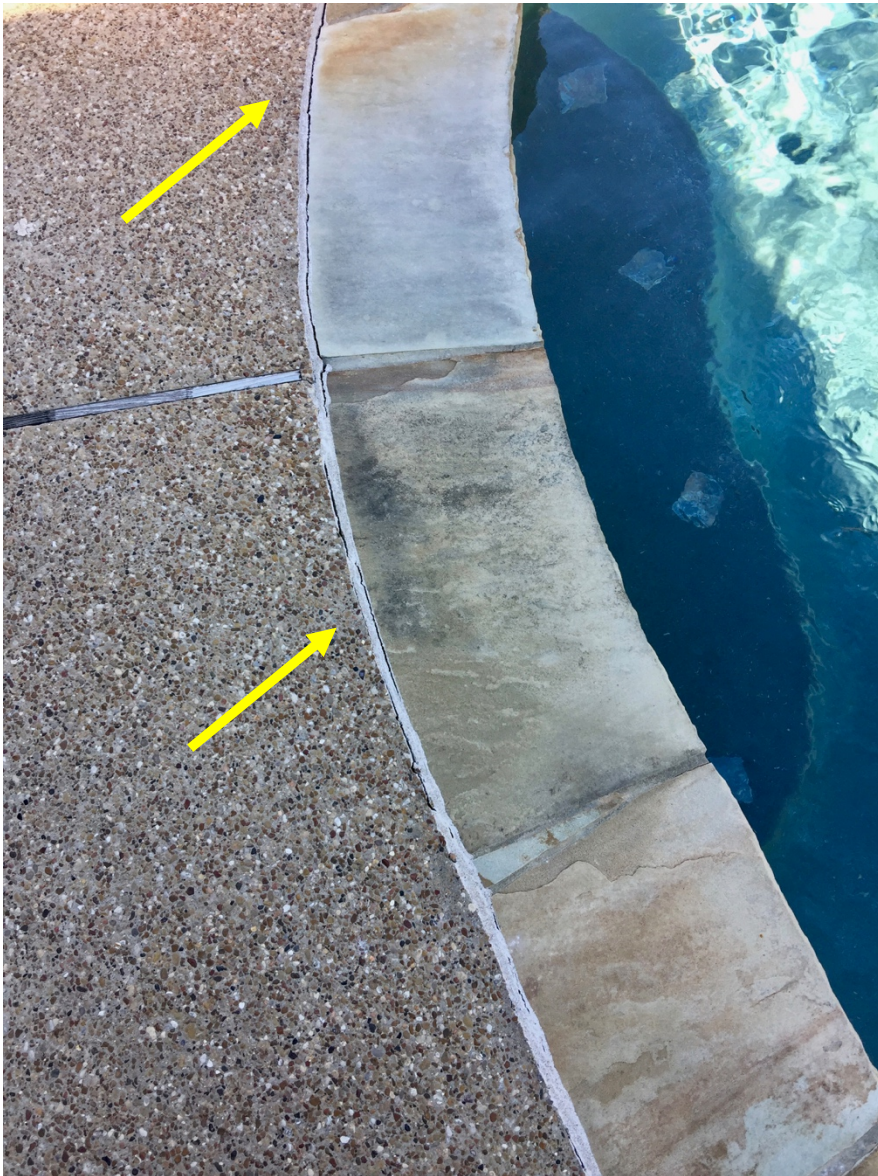
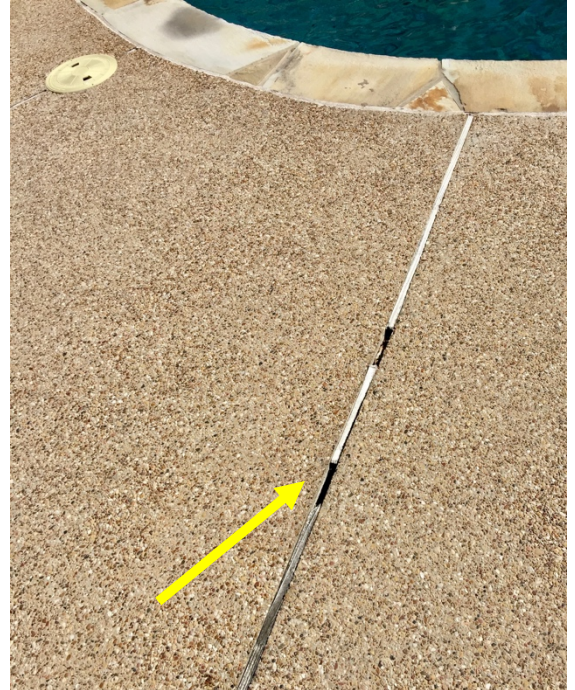
Coping around pool edge is cracked and separated from deck. This situation can allow water/snow/ice to form below deck causing failure of the coping or cracking of the deck.

Recommendation: Remove all old mastic and replace with appropriate seal rated for use around pool. Monitor seasonally to insure integrity of the bond and sealant.
