ARIEL Inspections LLC

PROPERTY INSPECTION REPORT

Concerning: 000 Name Street, Dallas, Texas 75201

February 1, 2017

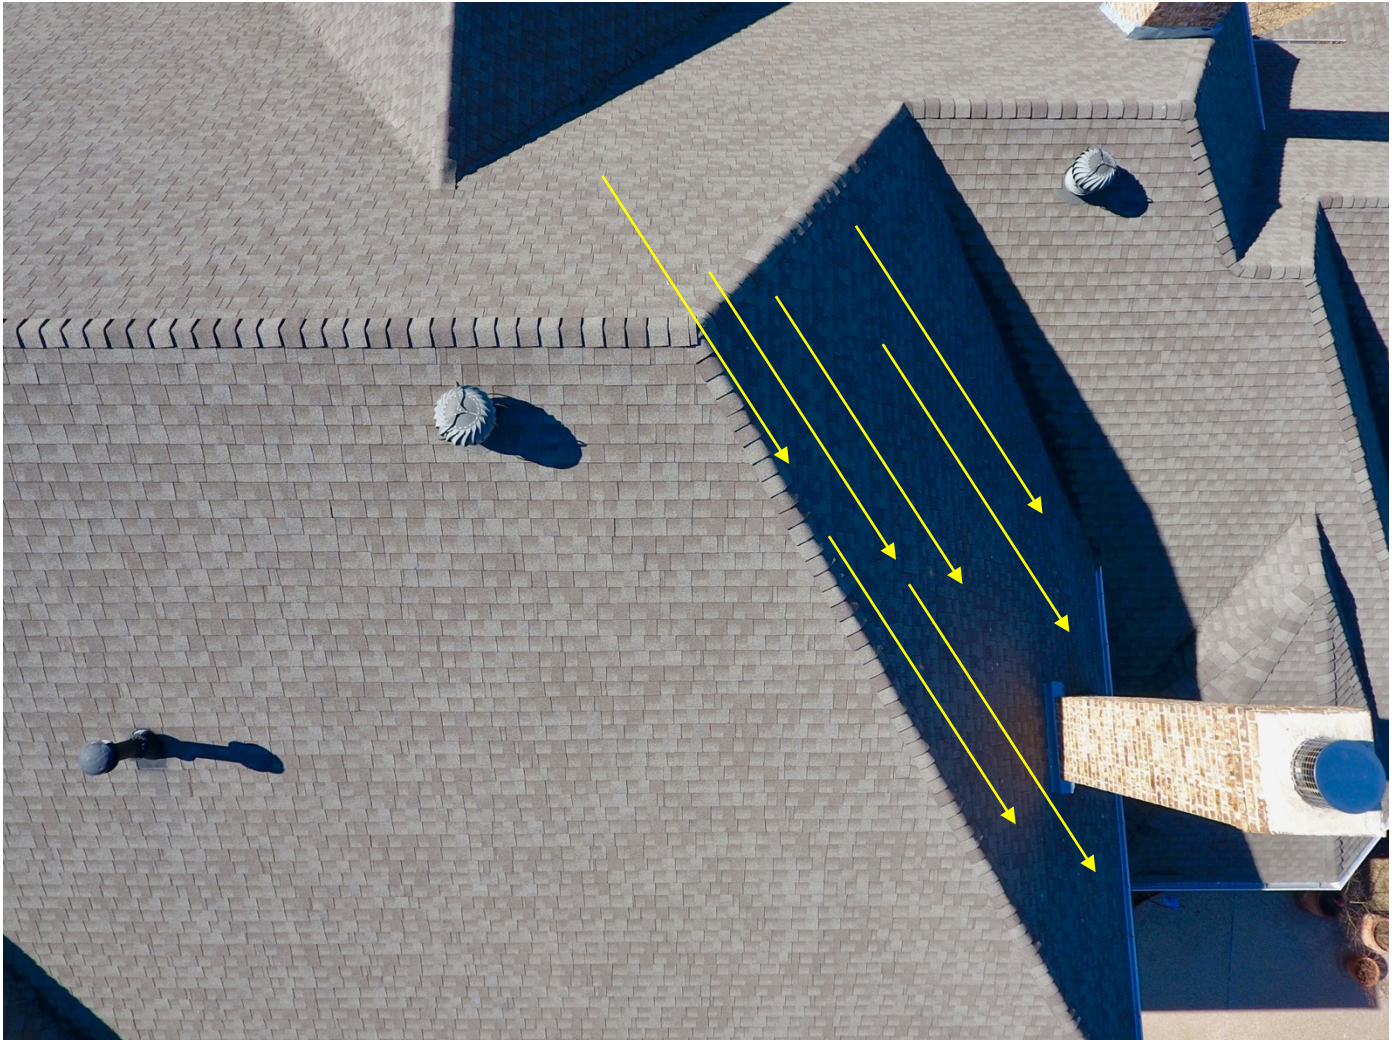
Previously patched and sealed nail heads

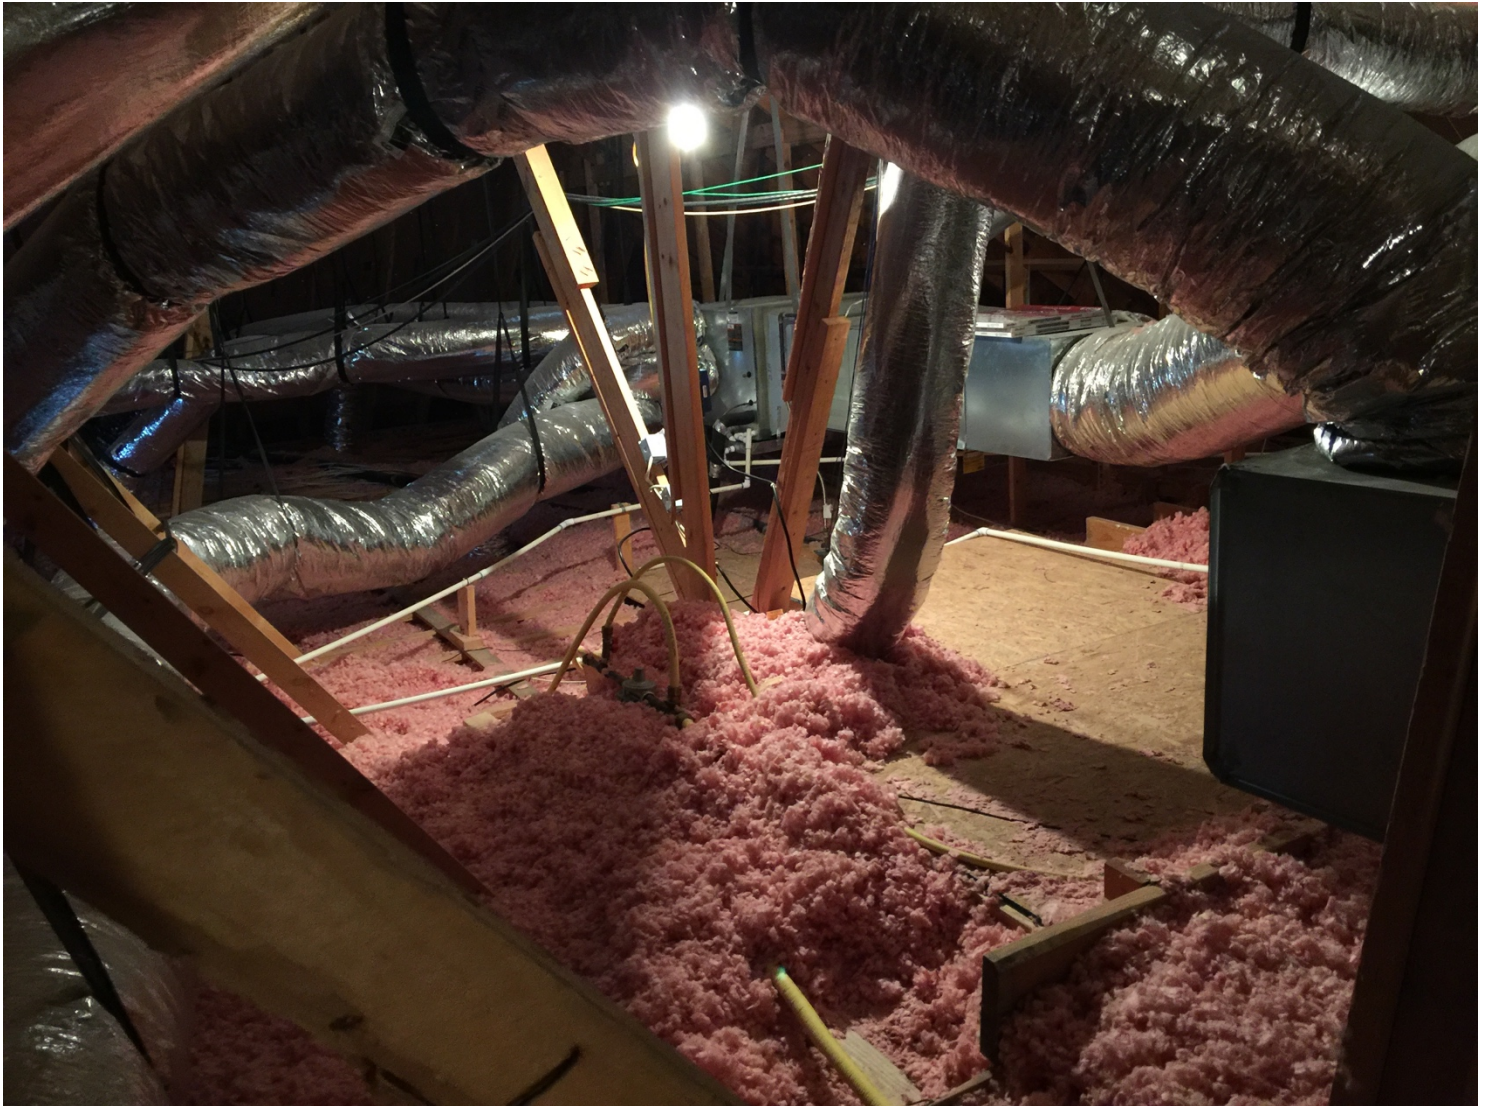
The attic was performing its intended purpose to support the roof and provide sufficient insulation for the interior of the house.

Insulation was noted at being an average depth of approximately 8 inches overall. Some areas were covered with spun fiberglass up to 12 inches deep but some areas were less than 5 inches and a few areas were missing insulation.

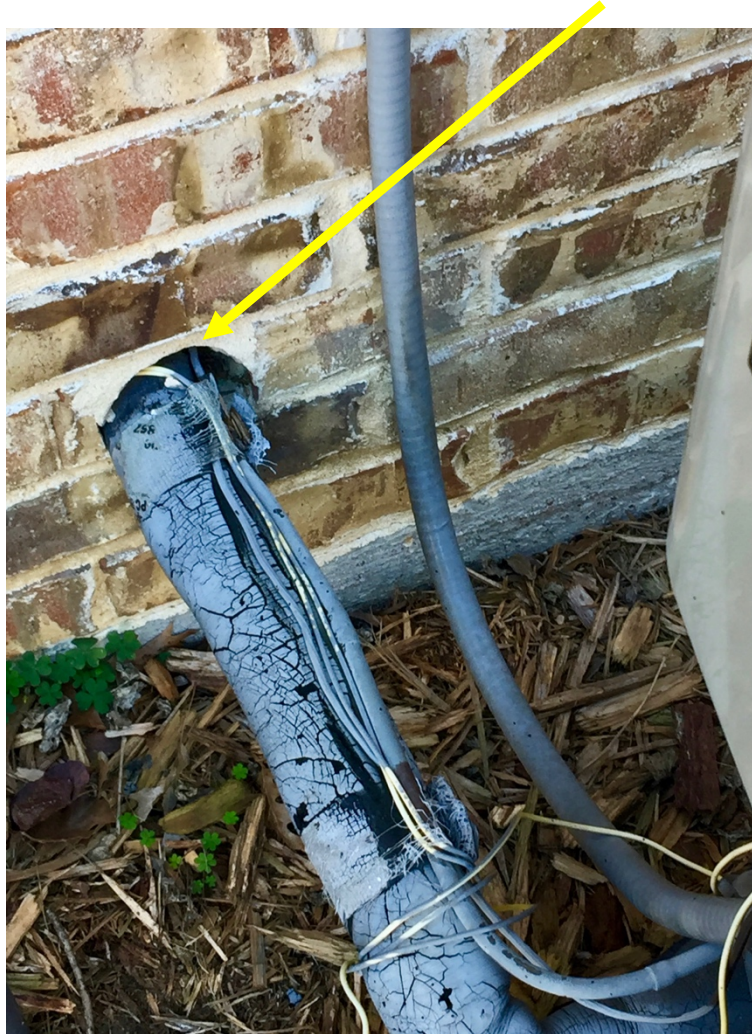
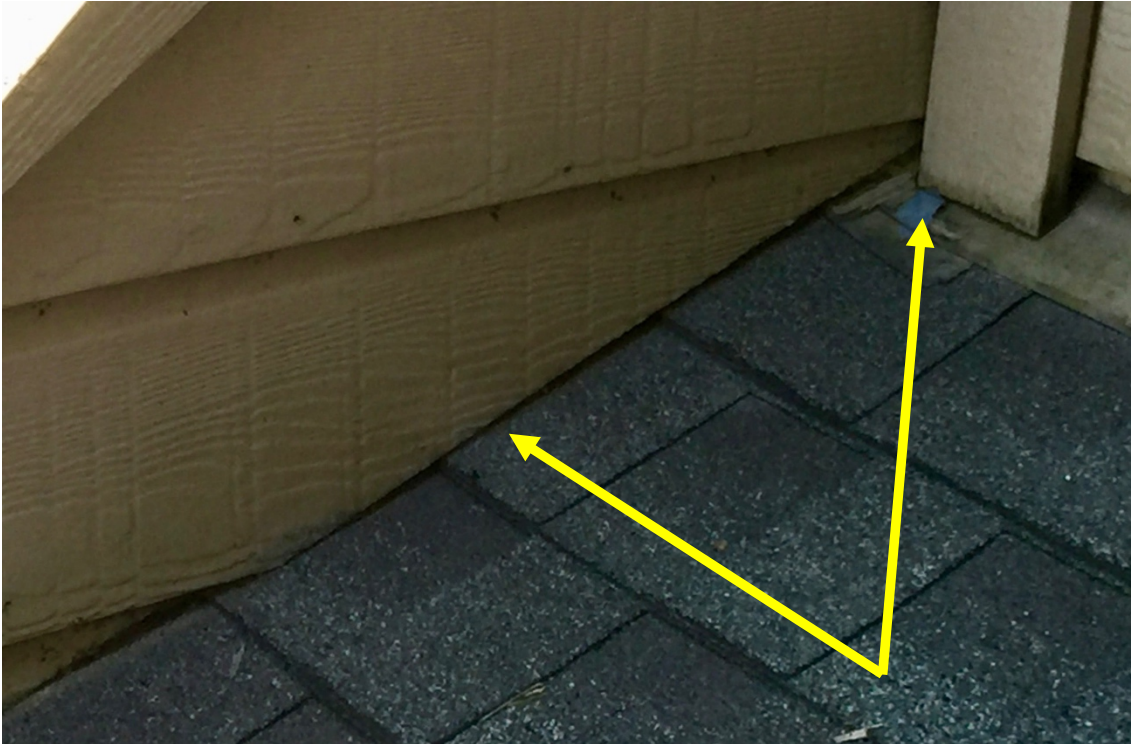
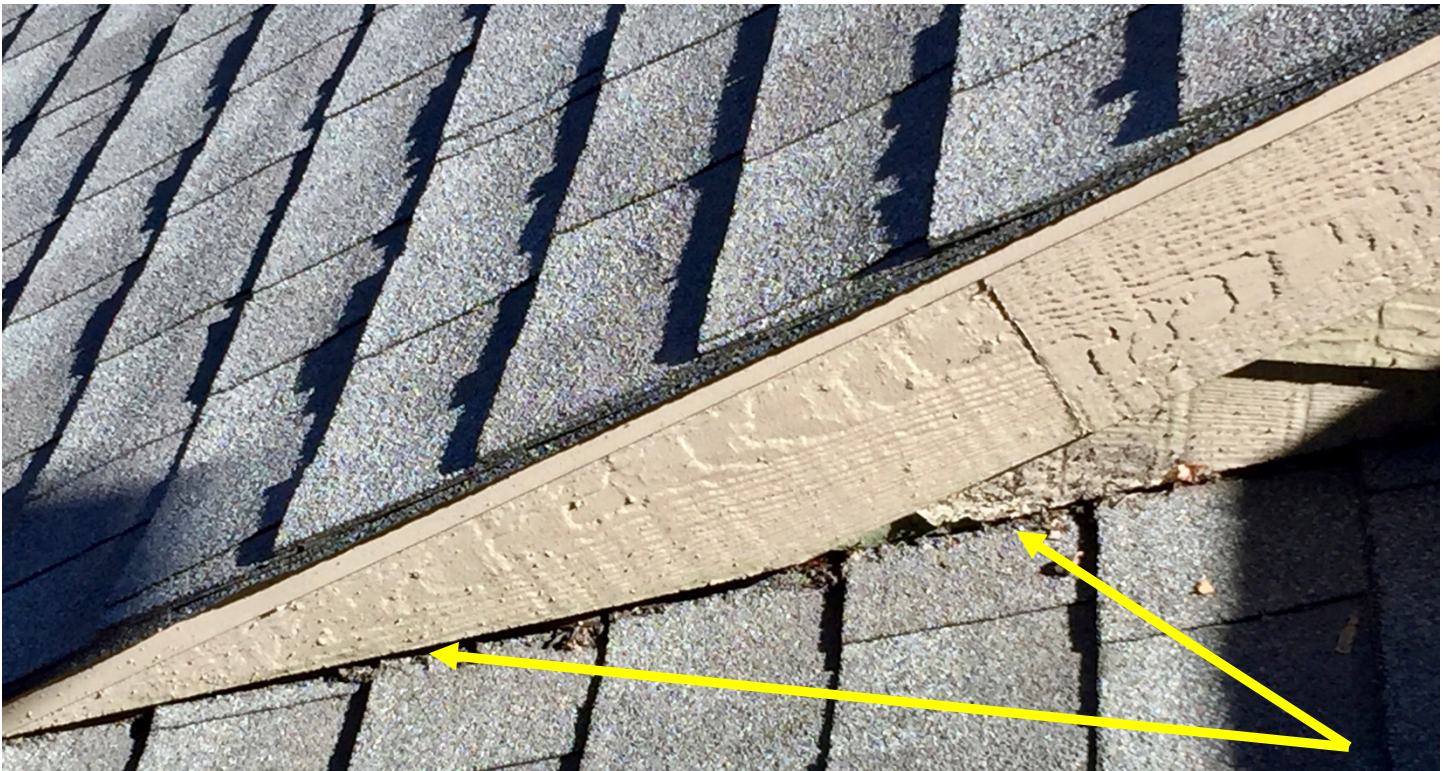
Exterior Wall: There were no deficiencies observed other than minor penetrations that require caulking/silicone sealant to be applied.

Comments: Exterior walls should be inspected by a professional painter yearly to assure long life of caulking and sealant materials. This is especially true around window sashes and stiles on the exterior. Condensation can form at the window sill resulting in peeling paint, staining and wood rot if not protected properly.

Recommend kick outs near adjoining walls to redirect water away from brick and hardy board siding.

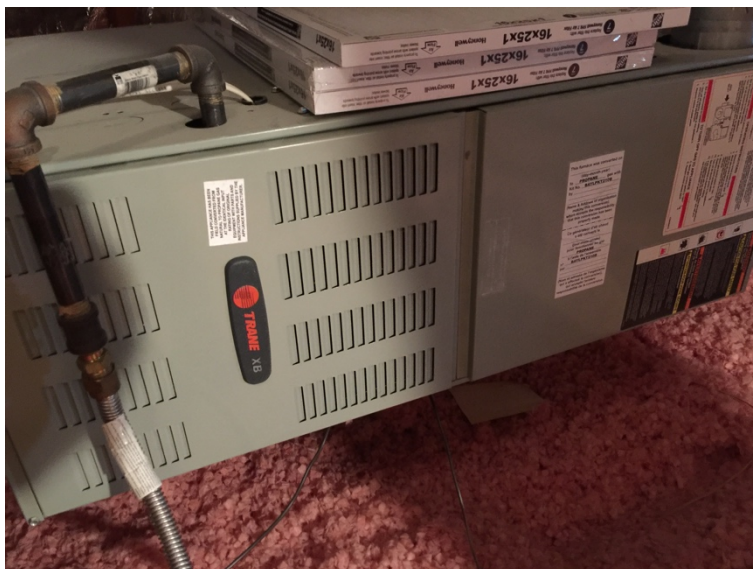
Cooling Equipment High/Low Differential: 41° Cooling 17°

The Trane XB 13's are probably at half of their useful lives (>10 years old)

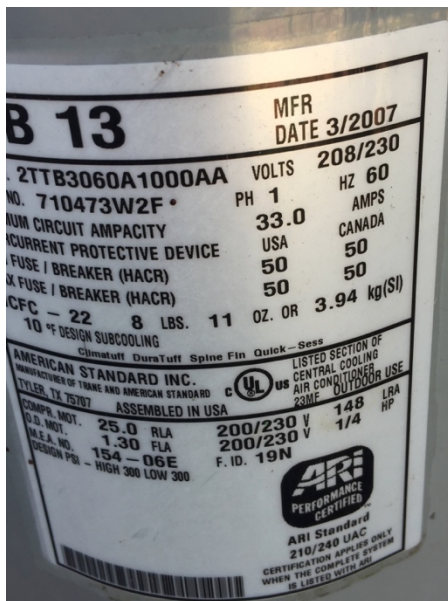
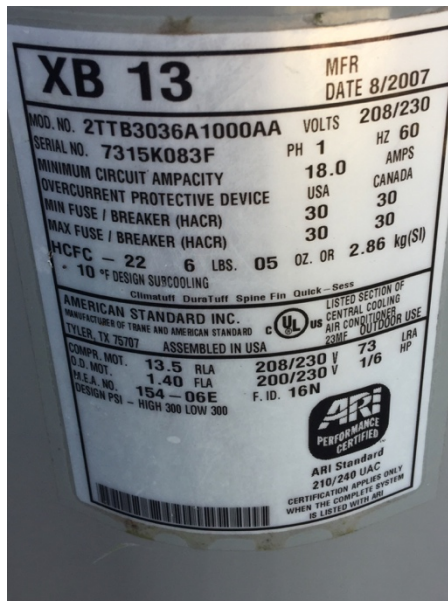
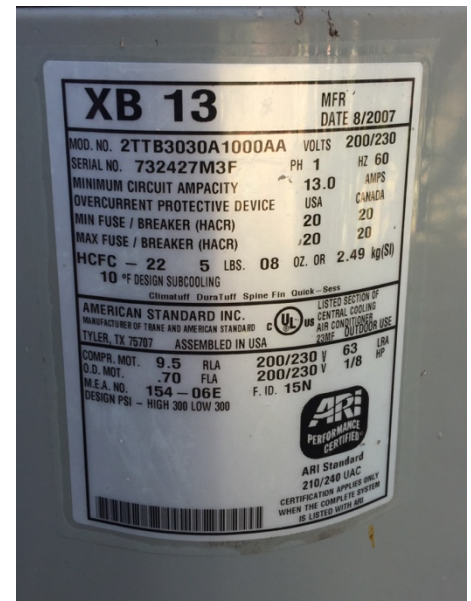
Average SEER rating 13.5 nominal

All manufactured 2007 they are 10 years into average life of 15-20 years if properly maintained and serviced at least twice annually

Recommendation: Filters should be changed monthly to maintain clean evaporator coils.

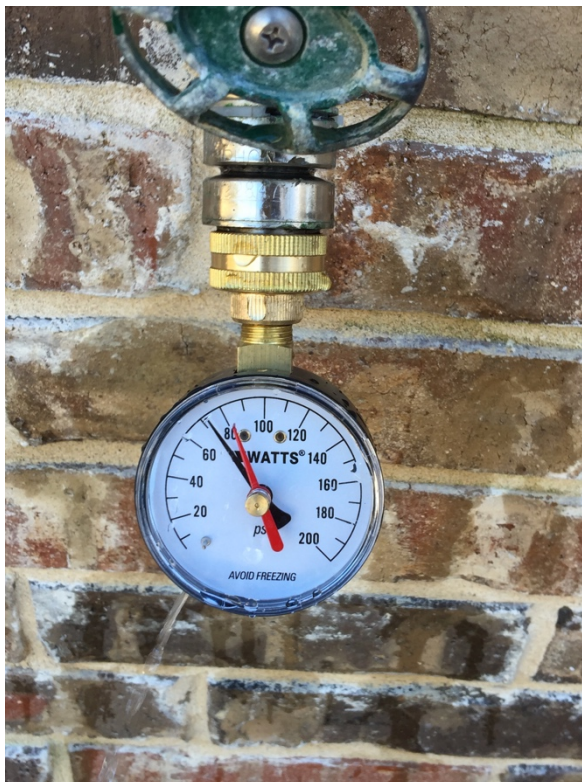
Fixture Shut Off Valves were present on all sinks

Water pressure reducer should be installed along with anti-siphon valves to eliminate possibility of cross connections into drinking supply.

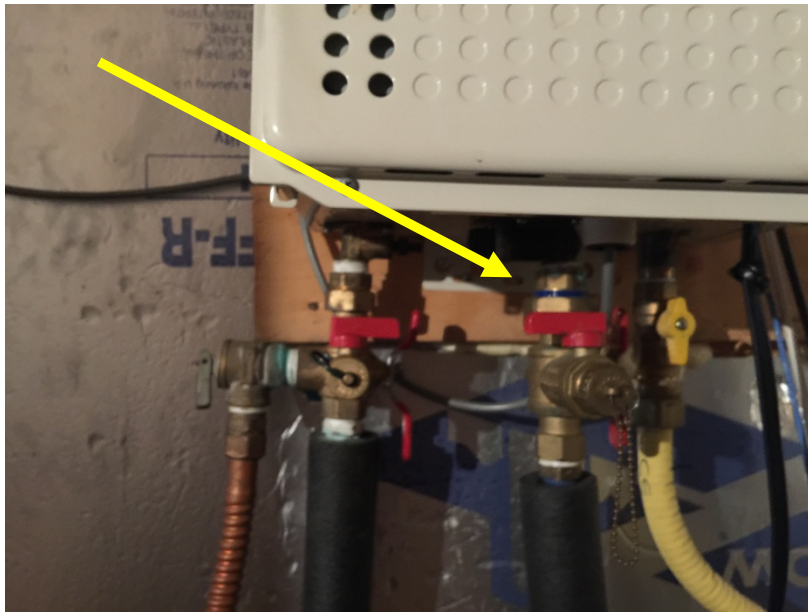
Temperature & Relief Valves were properly installed on the unit. The gas line was flex and there was a shut off valve for the gas as well as a shut off for the cold-water intake. A drip leg was not evident for clean out of gas line debris and water infiltration.

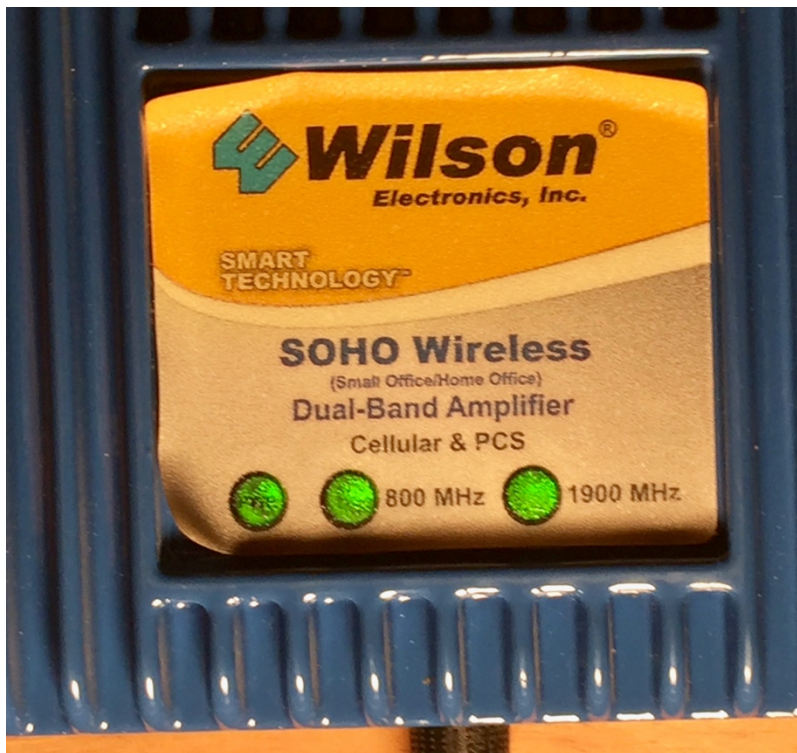
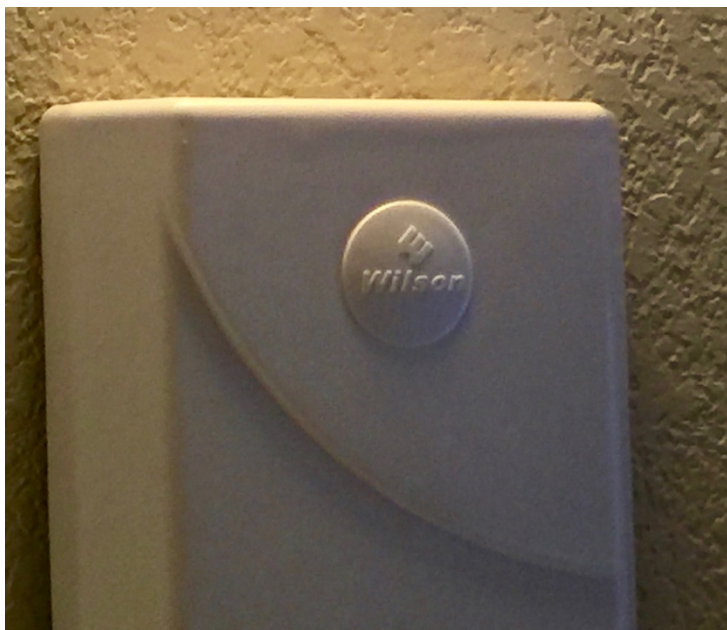
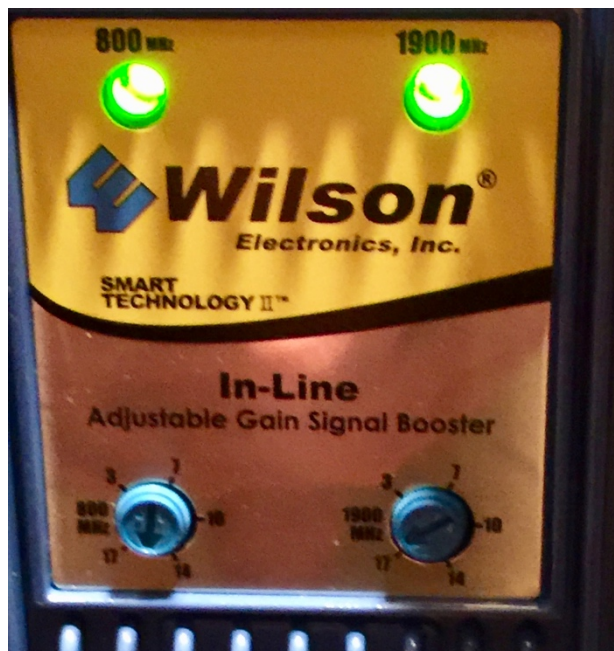
Wireless routers and WiFi boosters were operating normally and provide good signal strength (> 5 bars reception) The hub is in the upstairs hall at top of staircase. Dual amplifiers are in the upper attic adjacent to the north furnace system

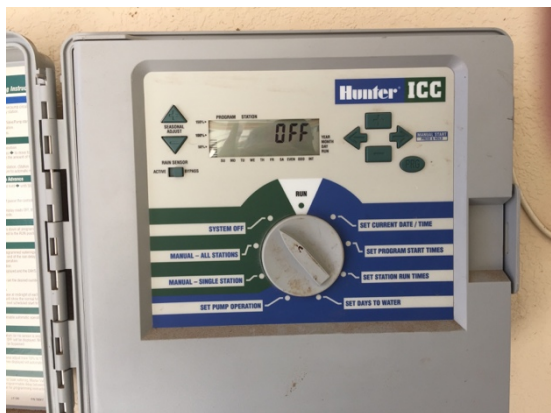
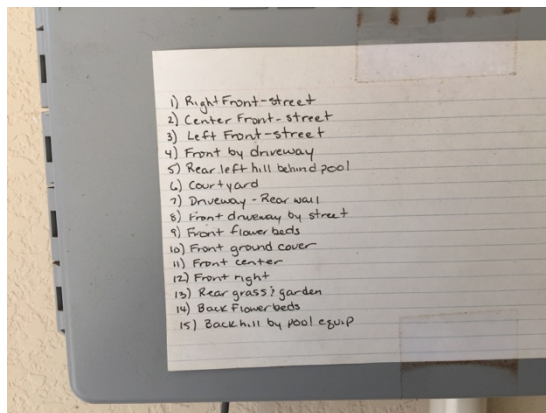
- Front & Side System was observed working properly at each station. Appeared to provide adequate coverage for front lawn. No adjustments required.
- Backyard System was observed working properly at each station. Appeared to provide adequate coverage for rear yard lawn.

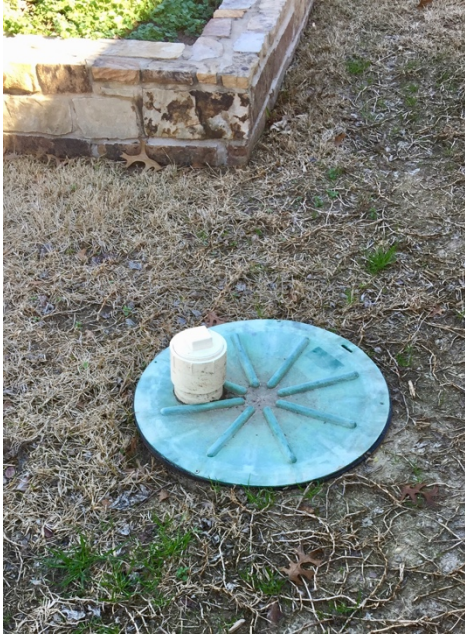
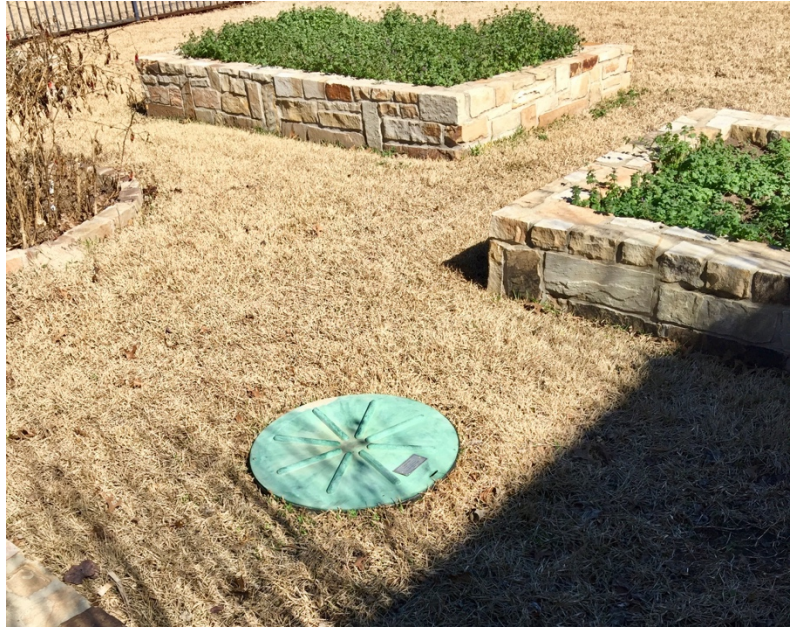
Unit was clearly label by circuit. Irrigation is supplied by well water system located in the west lawn area.

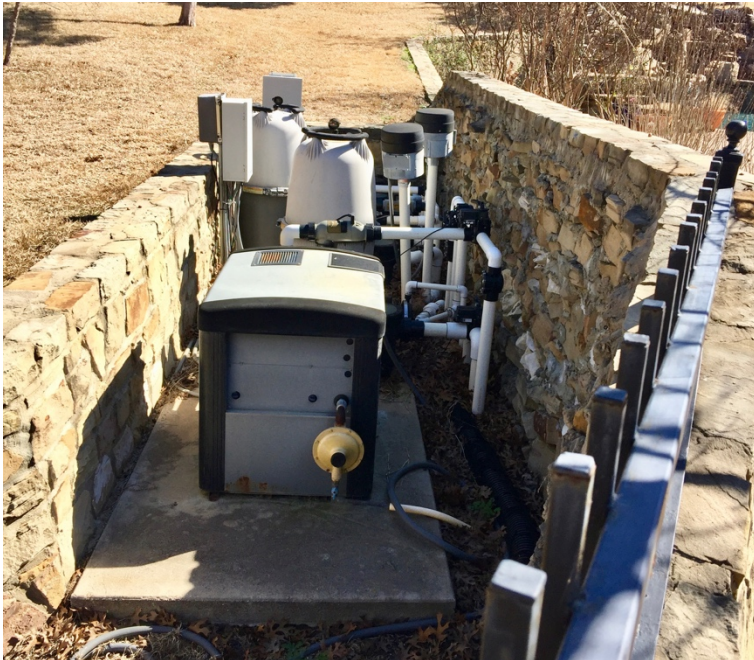
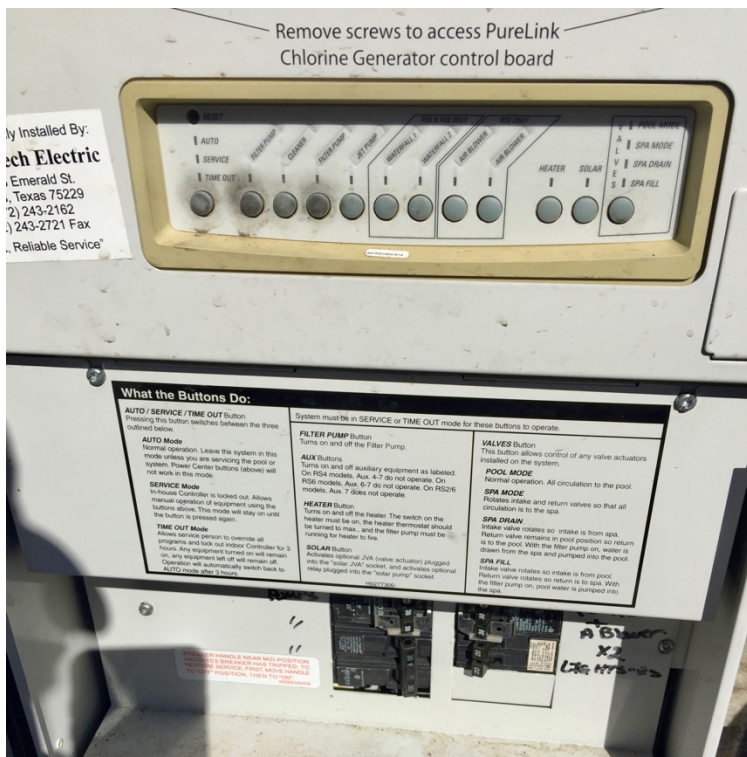
All systems & pumps were operating and able to be controlled from direct service panel and from inside wall mounted panel in kitchen area by rear door.

The control systems are manufactured by Aqualink

The system has an automatic chlorinator however at time of the inspection it was noted that additional chlorine tablets were placed inside the filter traps at pool edge.

The chlorinator was operating properly so further investigation with the owner should be followed up to understand if the chlorinator is providing proper amounts of chemical to the pool.
